Table of Contents

Inspector Name Darren Anderson
Company Name Anderson Home Inspection Service, LLC

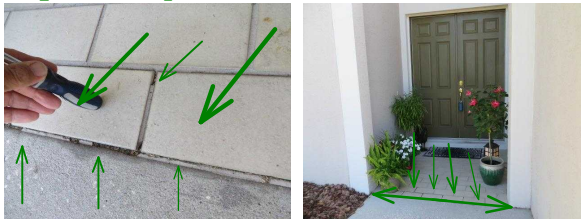
Porch: Tile, Covered A few of the leading edge tiles are loose/not securely fastened to the concrete slab and some of the grout joints are cracking and loose. Recommend further evaluation and repairs by a licensed contractor.

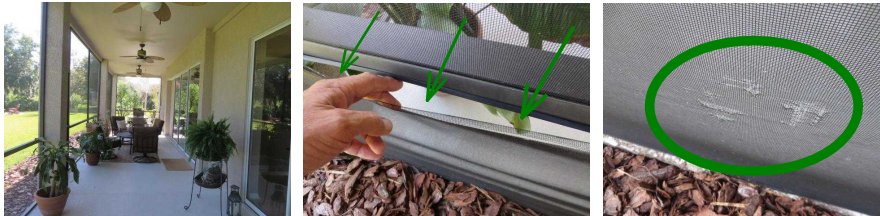
Patio: Concrete, Concrete, Screen enclosed A lower screen panel on the left end of the enclosure is not attached along one connection. Observed a few screen panels that are torn. A qualified contractor is recommended to evaluate and estimate repairs.

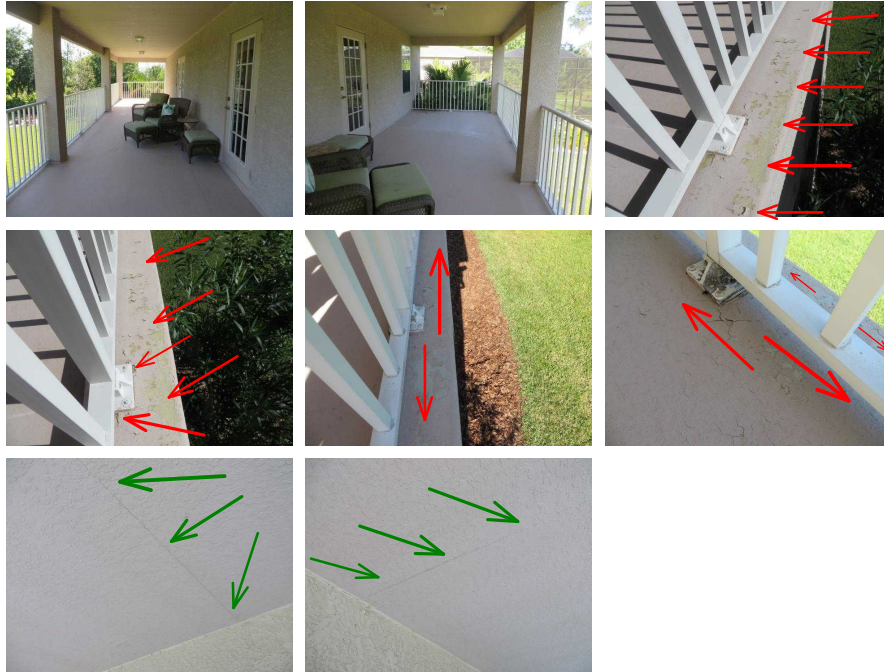
Balcony (continued)

Balcony Covered, Metal railings, Painted fiberglass decking
Observed some peeling paint which is exposing the fiberglass along the perimeter of the decking which will cause failure and leaks will occur if this condition is not repaired promptly. The most typical place for leaks is at the railing penetrations which needs to be maintained and caulked to prevent failure.
Observed some cracked/loose ceiling drywall joints that needs repair.
Recommend further evaluation and repairs by a licensed contractor prior to commitment.

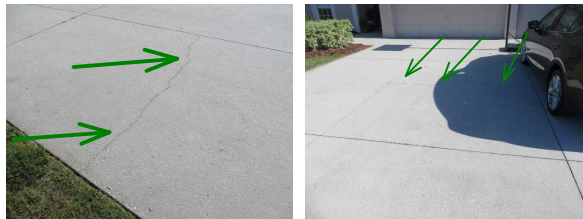
Driveway: Concrete Some cracks observed on the concrete slab. Suggest monitoring and repair as needed. The cracks do not appear to be a tripping or fall risk at this time. A qualified contractor is recommended to evaluate and estimate repairs.

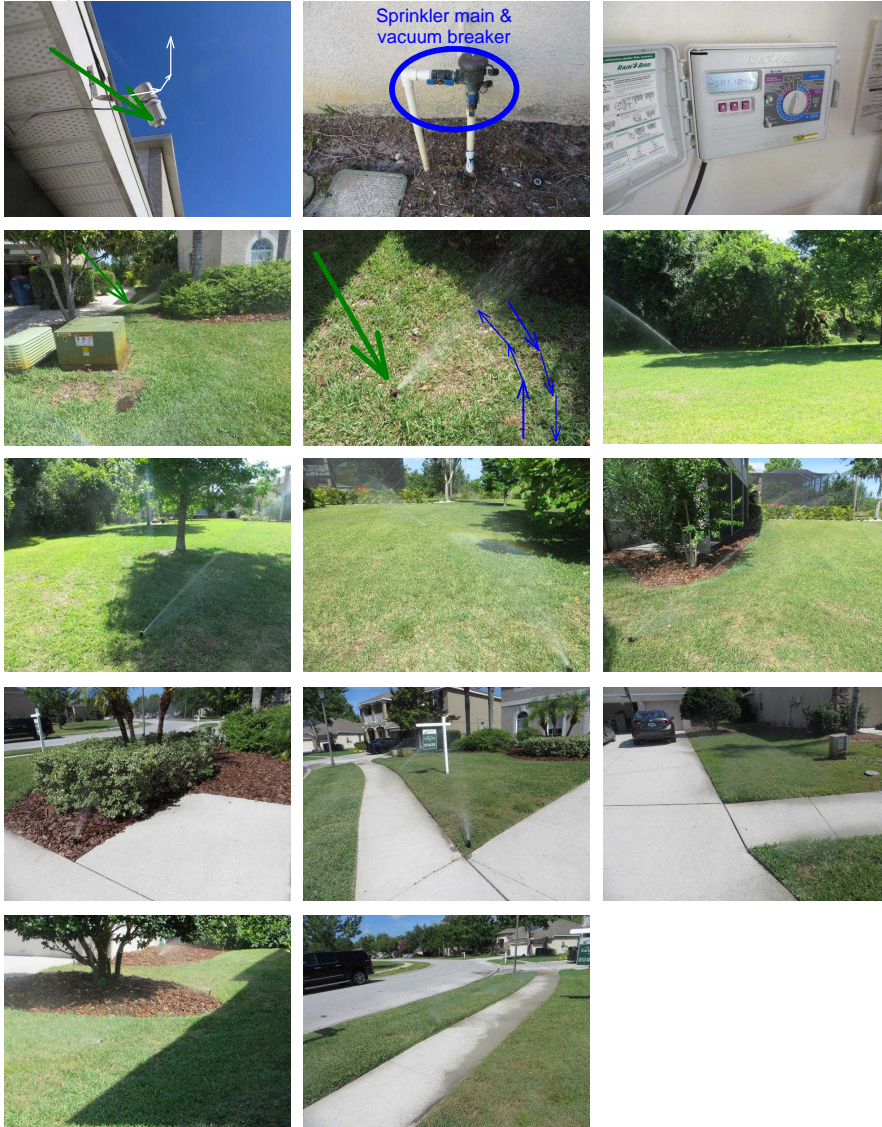
Lawn Sprinklers: (continued)

Lawn Sprinklers: Metered The rain sensor gauge is not pointing up which will not function properly. A rotating sprinkler head on the left side near the left front corner of the structure would not rotate when operated. Suggest evaluation/repairs by a licensed plumber.

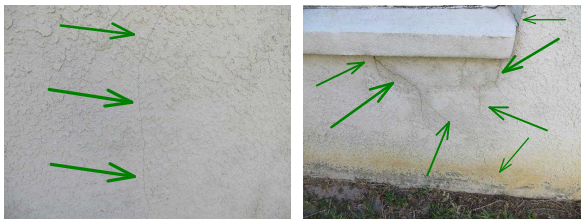
Type: Block with stucco 1st floor: Observed some cracking in some places in the block stucco walls on the exterior. This appears to be a typical condition and no structural defects related to this condition detected at the time of inspection.

Observed cracking in the stucco on the left side that has more cracks than typical. This condition may be related to the stucco being installed very thin, the paint needing updating or something that was not identified.

Typically, an elastomeric type sealant is used to patch the cracks and then touched up with paint. A qualified contractor is recommended to evaluate this issue and make repairs.

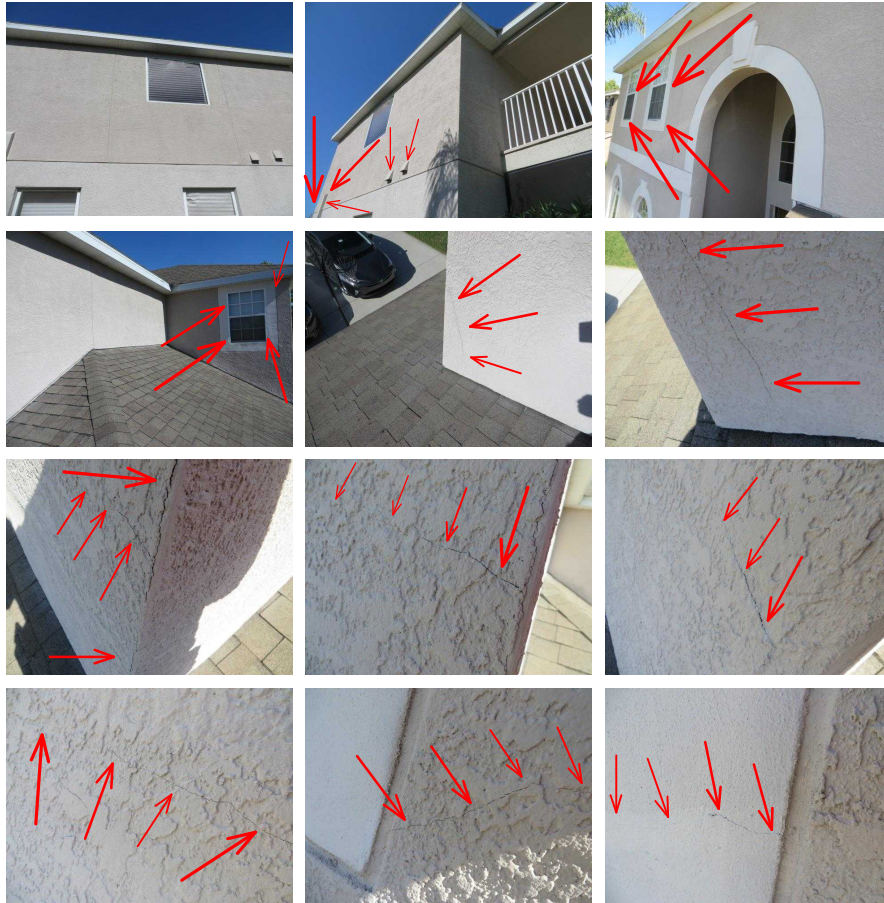
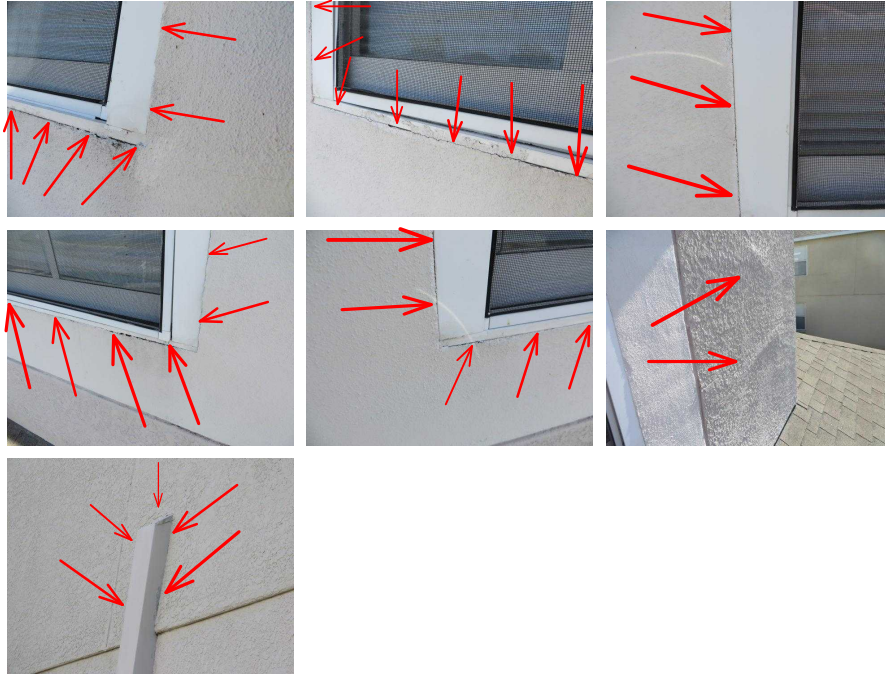
Type: Framed with stucco 2nd floor: Did not see isolation/Urethane caulk joints around the second floor exterior window penetrations or other penetrations. Observed voids around the window exterior perimeter which appears to be a substandard condition and can allow water intrusion, water damage, mold and a chain of events. Observed some stucco cracking in some places at window corners, in/near the wall corners and in some places in the field of the stucco surface. Observed some bulging which appears to be from delamination of the stucco in some places and the worst observed is the front wall on the right side. The condition in the wall cavity under the stucco was not visible and it is very common for water damage and moldy substances to be present due to these conditions.

These stucco conditions do not appear to meet minimal ASTM standards.

Recommend further evaluation and repair by a licensed stucco contractor prior to commitment.

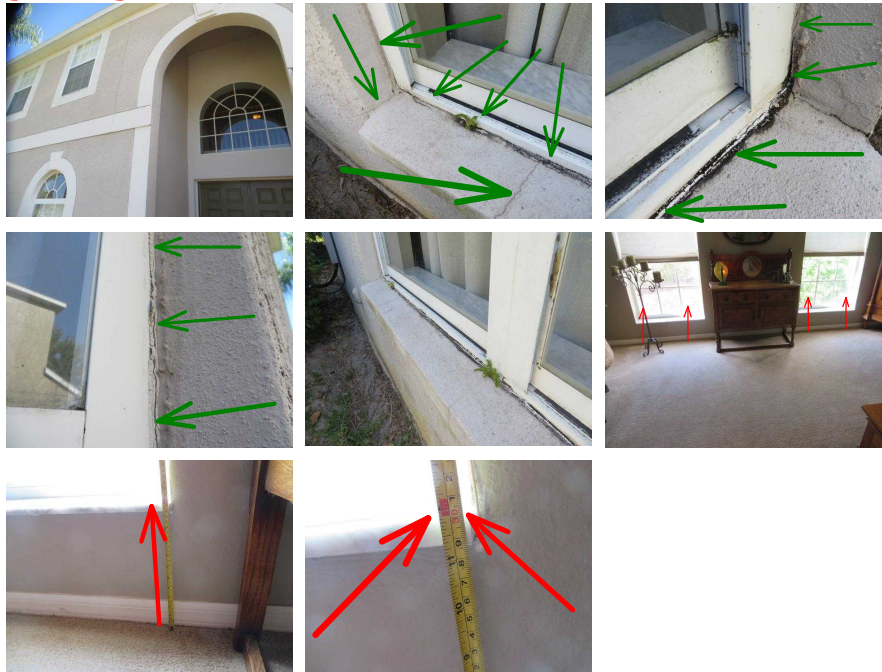
Windows: Aluminum, Single hung, Fixed in place, Single pane glazing, Sliding **Observed voids and loose caulking around the exterior window perimeter in some places which can allow water intrusion. There is some moldy caulking present with plant growth growing out of the caulking which indicates that moisture is being trapped under the caulking.**
There are two windows in the living room and the lower glazing for each window is less than 18 inches from the floor and the glazing did not appear to be etched to indicate the presence of tempered safety glass. Current Florida Building Code requires glazing within 18 inches of the floor to be safety glass. Recommend further evaluation by a licensed Glazer contractor. 2406.3 Identification of safety glazing.
Except as indicated in Section 2406.3.1, each pane of safety glazing installed in hazardous locations shall be identified by a

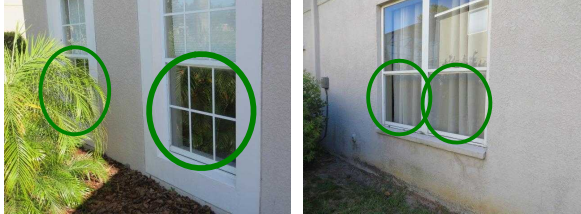
Window Screens: Vinyl mesh Missing two of the front facing first floor window screens. Missing two of the left facing first floor window screens. A qualified contractor is recommended to evaluate and estimate repairs.

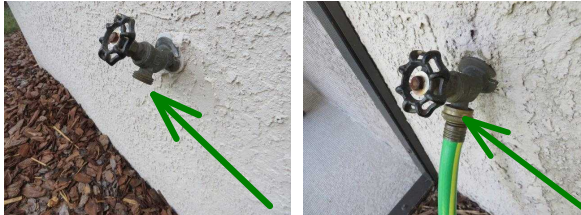
Hose Bibs: Rotary Missing anti-siphoning valves to prevent contaminated water from siphoning back into the domestic water supply. A licensed plumber is recommended to evaluate and estimate repairs.

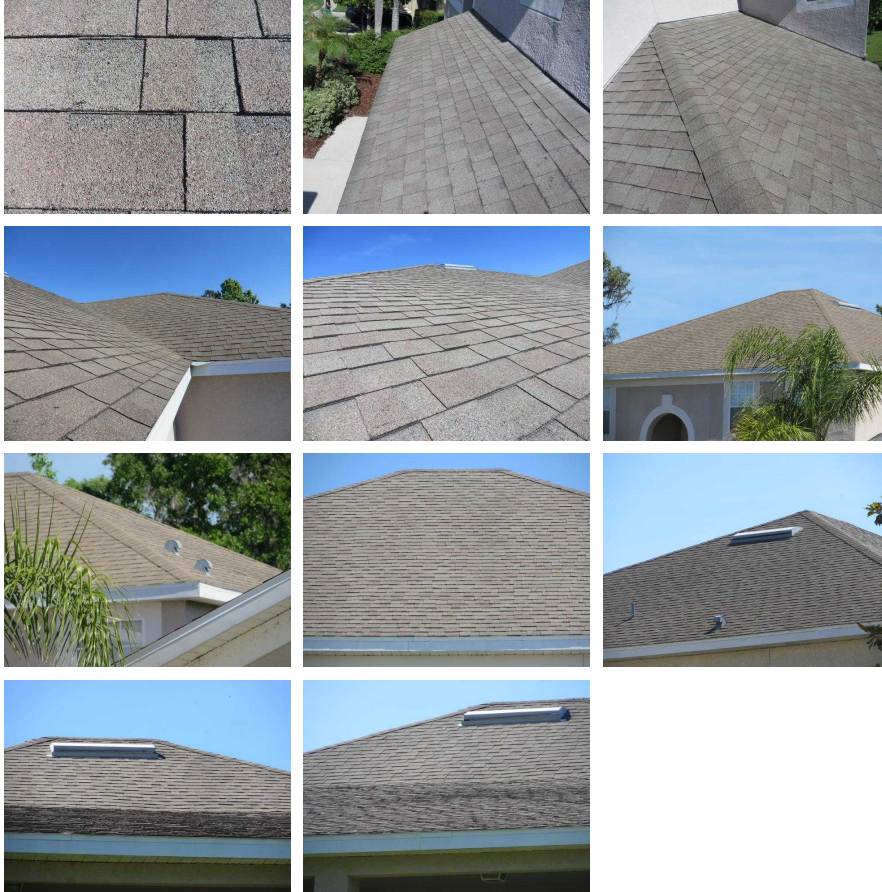
3. Functional Material: Asphalt shingle The roof covering material appears to have an estimate of 6 to 8 years of remaining life.

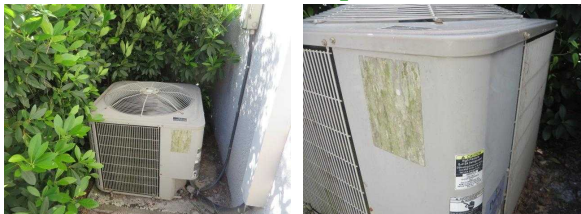
A/C System Operation: Functional at time of inspection The unit is nearing the end of its useful life. Recommend budgeting for unexpected repairs or replacement as failure can happen in the near future. Recommend obtaining a home service policy to cover such failures. The service record was not provided. Expect a limited life of the current system. Plants are growing too close to the unit and should be trimmed for sufficient air flow. The manufacturers label is worn off or missing which prevented identifying the system components, the age and size was estimated. A qualified air conditioning contractor is recommended to evaluate the HVAC system and make repairs.

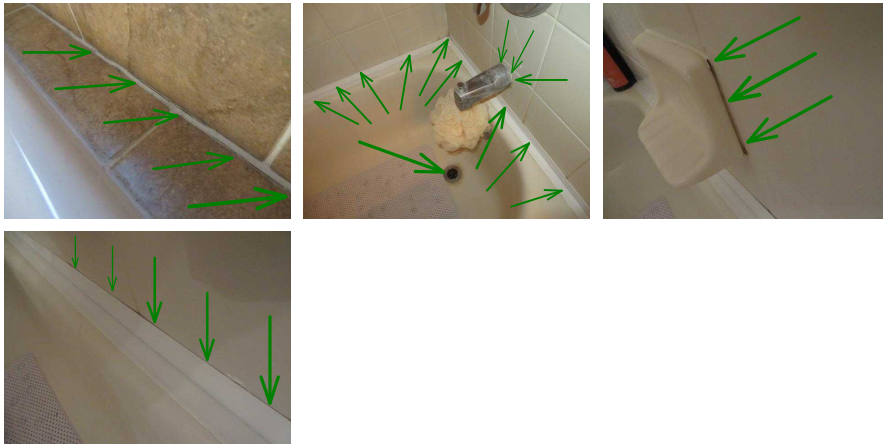
Tub/Surround: Fiberglass tub, Ceramic surround Master bathroom: Observed loose caulking with voids at the tub stand ceramic tiles that needs updates to prevent water intrusion and to prevent water damage.

Suggest evaluation and repairs by a licensed plumber.

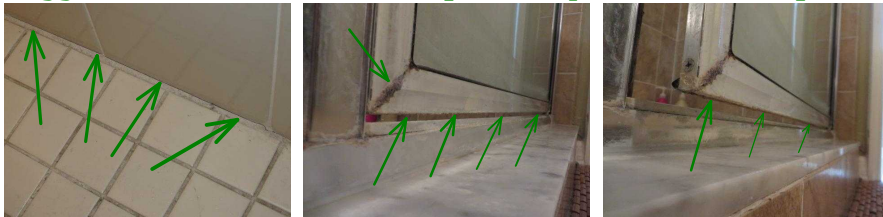
Shower/Surround: Ceramic 1st floor bathroom: Observed some voids at the shower pan perimeter that needs grout/caulking updates to prevent trapping moisture and to prevent water intrusion.

Suggest evaluation and repairs by a licensed plumber.

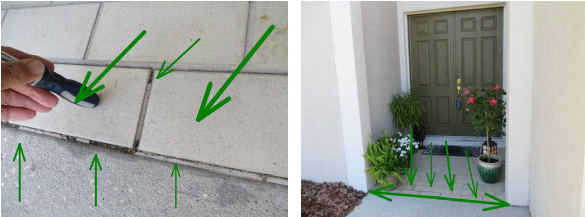
1. Porch: Tile, Covered A few of the leading edge tiles are loose/not securely fastened to the concrete slab and some of the grout joints are cracking and loose. Recommend further evaluation and repairs by a licensed contractor.

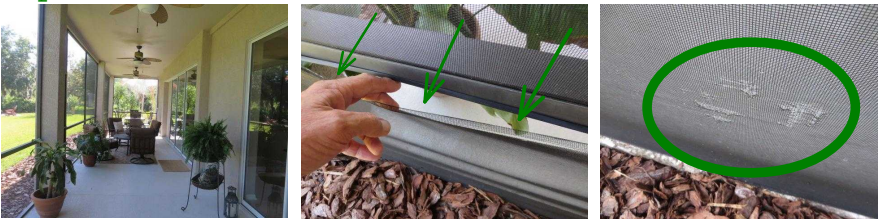
2. Patio: Concrete, Concrete, Screen enclosed A lower screen panel on the left end of the enclosure is not attached along one connection. Observed a few screen panels that are torn. A qualified contractor is recommended to evaluate and estimate repairs.

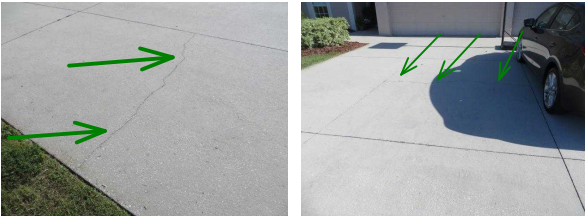
3. Driveway: Concrete Some cracks observed on the concrete slab. Suggest monitoring and repair as needed. The cracks do not appear to be a tripping or fall risk at this time. A qualified contractor is recommended to evaluate and estimate repairs.

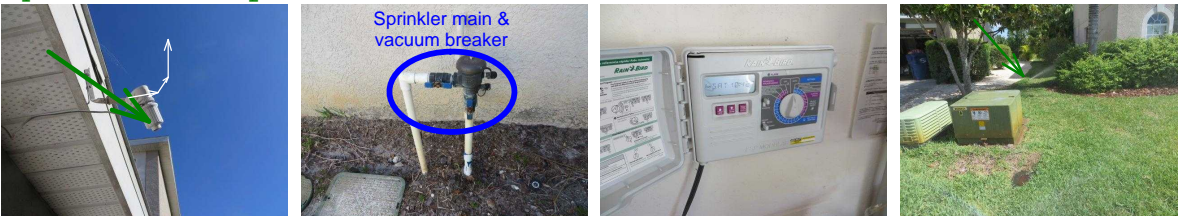
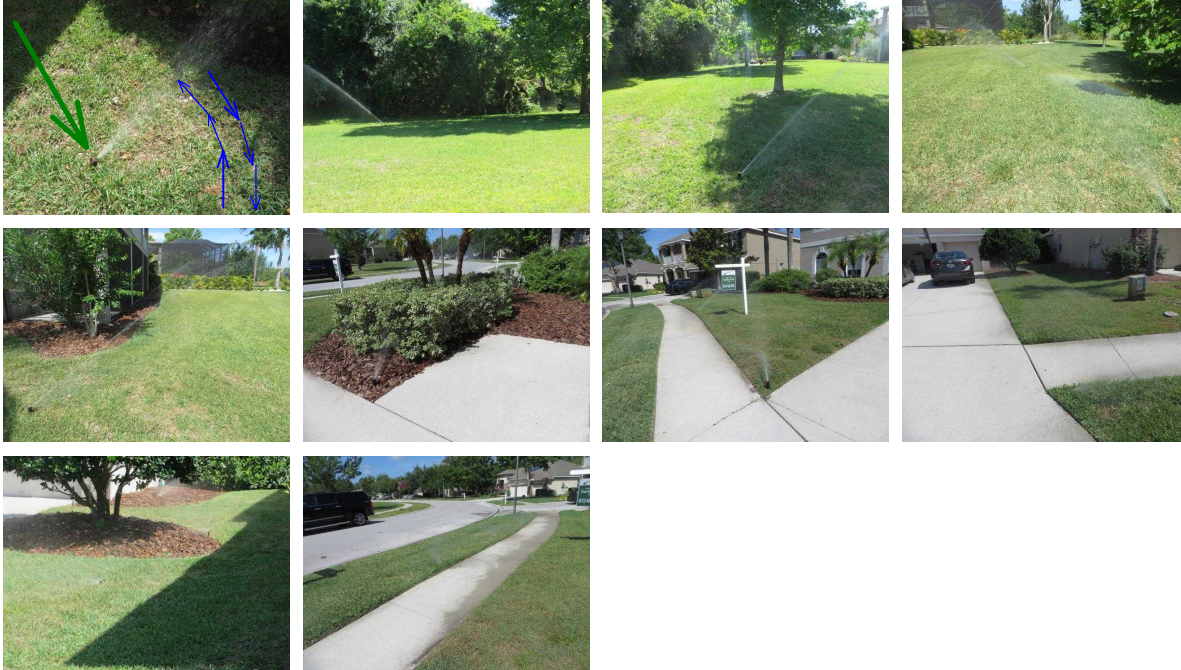
4. Lawn Sprinklers: Metered The rain sensor gauge is not pointing up which will not function properly. A rotating sprinkler head on the left side near the left front corner of the structure would not rotate when operated. Suggest evaluation/repairs by a licensed plumber.

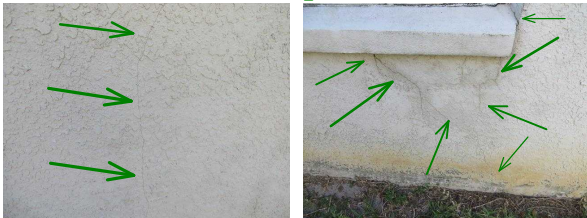
5. 1st Floor Exterior Surface Type: Block with stucco 1st floor: Observed some cracking in some places in the block stucco walls on the exterior. This appears to be a typical condition and no structural defects related to this condition detected at the time of inspection.

Observed cracking in the stucco on the left side that has more cracks than typical. This condition may be related to the stucco being installed very thin, the paint needing updating or something that was not identified. Typically, an elastomeric type sealant is used to patch the cracks and then touched up with paint. A qualified contractor is recommended to evaluate this issue and make repairs.

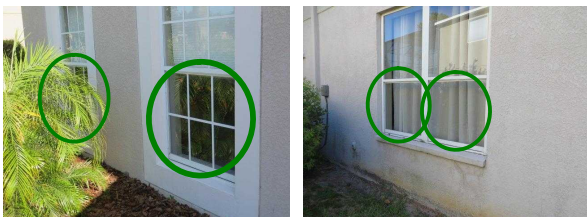
6. Window Screens: Vinyl mesh Missing two of the front facing first floor window screens. Missing two of the left facing first floor window screens. A qualified contractor is recommended to evaluate and estimate repairs.

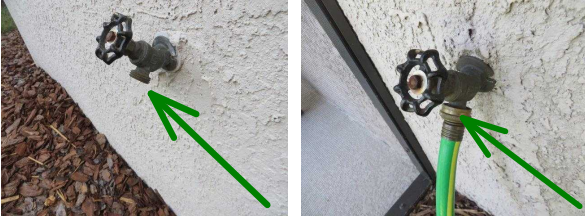
7. Hose Bibs: Rotary Missing anti-siphoning valves to prevent contaminated water from siphoning back into the domestic water supply. A licensed plumber is recommended to evaluate and estimate repairs.

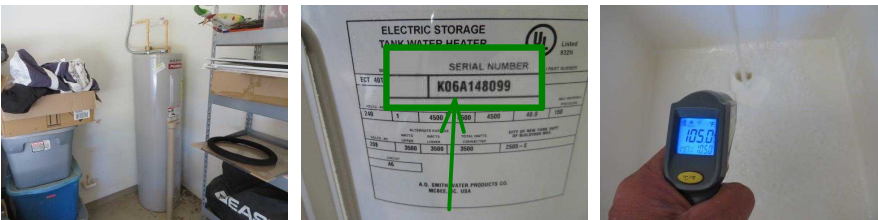
8. Garage Water Heater Water Heater Operation: Functional at time of inspection The water heater is nearing the end of its useful life of 8 to 12 years. Recommend budgeting for replacement as failure is likely in the near future and consider obtaining a home service policy. The service record was not provided. Expect a limited life of the water heater.

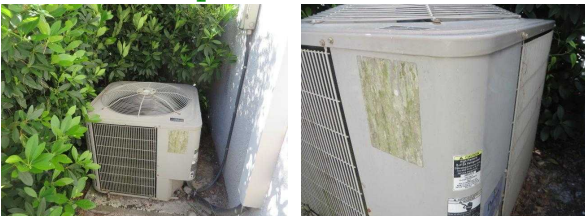
9. Pad mounted AC System A/C System Operation: Functional at time of inspection The unit is nearing the end of its useful life. Recommend budgeting for unexpected repairs or replacement as failure can happen in the near future. Recommend obtaining a home service policy to cover such failures. The service record was not provided. Expect a limited life of the current system.

A qualified air conditioning contractor is recommended to evaluate the HVAC system and make repairs.

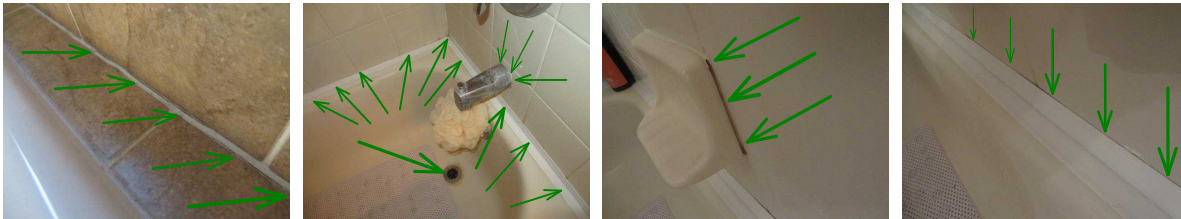
16. 3 bathrooms Bathroom Tub/Surround: Fiberglass tub, Ceramic surround Master bathroom: Observed loose caulking with voids at the tub stand ceramic tiles that needs updates to prevent water intrusion and to prevent water damage. 2nd floor hall bathroom: The tub stopper is missing. Observed voids around the faucet and around the soap dish which can allow water intrusion. There is a pressure sensitive vinyl trim that has been installed around the tub perimeter in place of caulking and this is a poor method of sealing the wall to the tub as water gets behind this trim and gets trapped. Suggest evaluation and repairs by a licensed plumber.

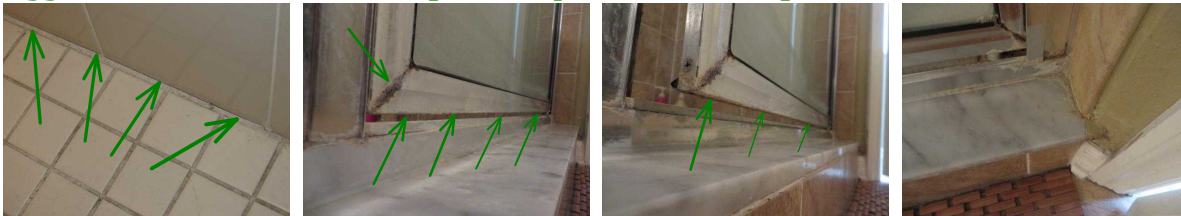
17. 3 bathrooms Bathroom Shower/Surround: Ceramic 1st floor bathroom: Observed some voids at the shower pan perimeter that needs grout/caulking updates to prevent trapping moisture and to prevent water intrusion. Master bathroom: The glass enclosure door is missing the bottom rubber seal/sweep to prevent water from splashing on the floor outside of the shower enclosure causing water damage. Suggest evaluation and repairs by a licensed plumber.

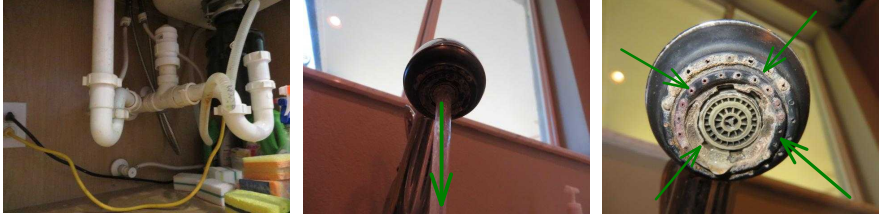
19. Primary kitchen Kitchen Plumbing/Fixtures: PVC traps The kitchen faucet (Hot and cold water) has very low water pressure. Most of the other faucets throughout the structure does not have low water pressure and this condition typically indicates that the aerator is partly clogged restricting the water flow. A licensed plumber is recommended to estimate repairs.

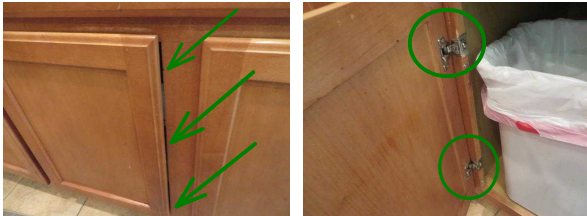
20. Primary kitchen Kitchen Cabinets: Wood The base cabinet door under the sink does not cover the opening and typically adjusting the hinges can move the door over to properly cover the cabinet opening. A qualified contractor is recommended to evaluate and estimate repairs.

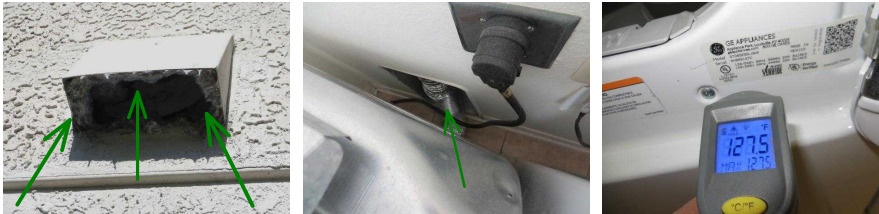
22. 1st Floor, Utility room Laundry Room/Area Dryer Vent & Dryer: Electric, Rigid metal behind walls, metal flex in laundry room Dryer vent is dirty (Dirty dryer vents are an increased fire risk). Recommend cleaning the dryer vent at least annually. Recommend evaluation and repairs by a licensed contractor.

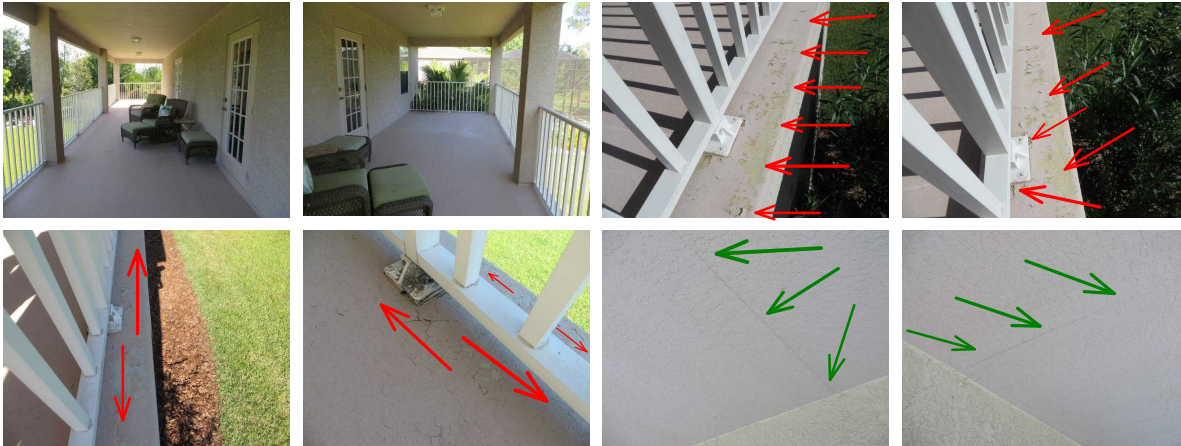
1. Balcony Covered, Metal railings, Painted fiberglass decking **Observed some peeling paint which is exposing the fiberglass along the perimeter of the decking which will cause failure and leaks will occur if this condition is not repaired promptly. The most typical place for leaks is at the railing penetrations which needs to be maintained and caulked to prevent failure. Observed some cracked/loose ceiling drywall joints that needs repair. Recommend further evaluation and repairs by a licensed contractor prior to commitment.**

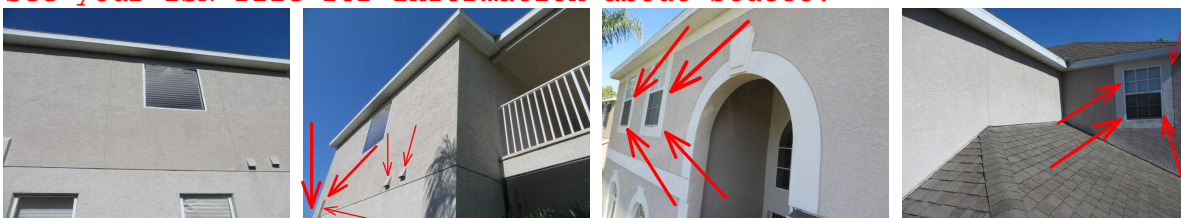
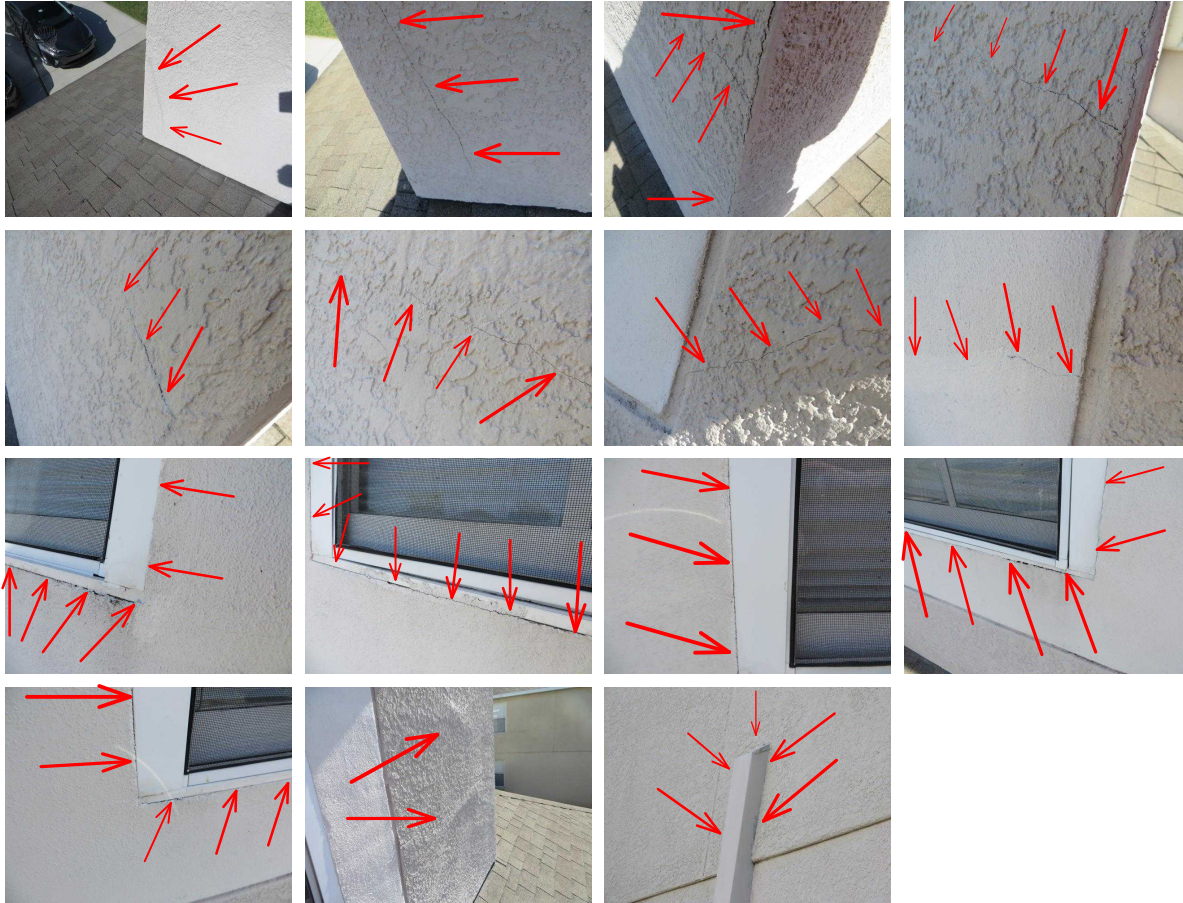
2. 2nd Floor Exterior Surface Type: Framed with stucco **2nd floor: Did not see isolation/Urethane caulk joints around the second floor exterior window penetrations or other penetrations. Observed voids around the window exterior perimeter which appears to be a substandard condition and can allow water intrusion, water damage, mold and a chain of events. Observed some stucco cracking in some places at window corners, in/near the wall corners and in some places in the field of the stucco surface. Observed some bulging which appears to be from delamination of the stucco in some places and the worst observed is the front wall on the right side. The condition in the wall cavity under the stucco was not visible and it is very common for water damage and moldy substances to be present due to these conditions. These stucco conditions do not appear to meet minimal ASTM standards. Recommend further evaluation and repair by a licensed stucco contractor prior to commitment. See your ISN file for information about stucco.**

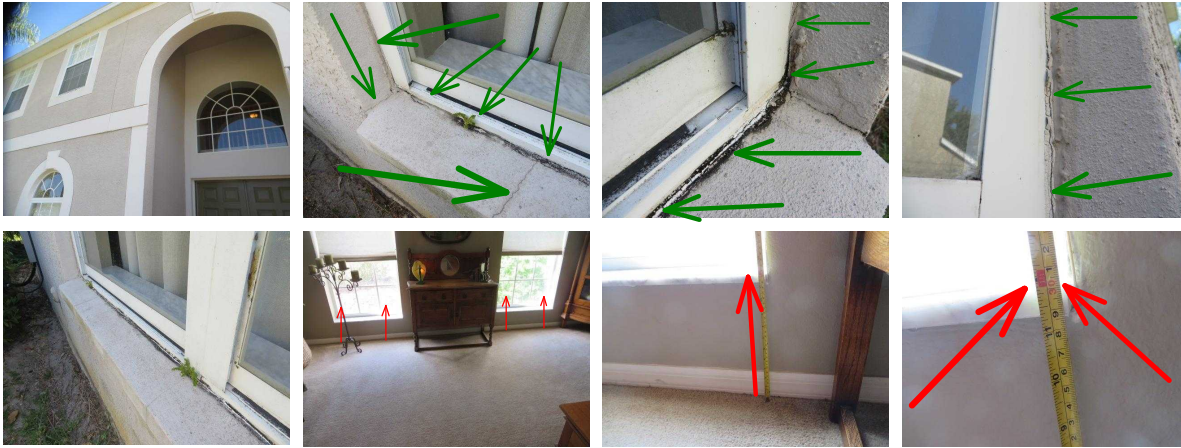
3. Windows: Aluminum, Single hung, Fixed in place, Single pane glazing, Sliding
Observed voids and loose caulking around the exterior window perimeter in some places which can allow water intrusion. There is some moldy caulking present with plant growth growing out of the caulking which indicates that moisture is being trapped under the caulking.
