Anderson Home Inspection Service, LLC

Page 1 of 25
Sample Lintel 04-22-2018.alb6

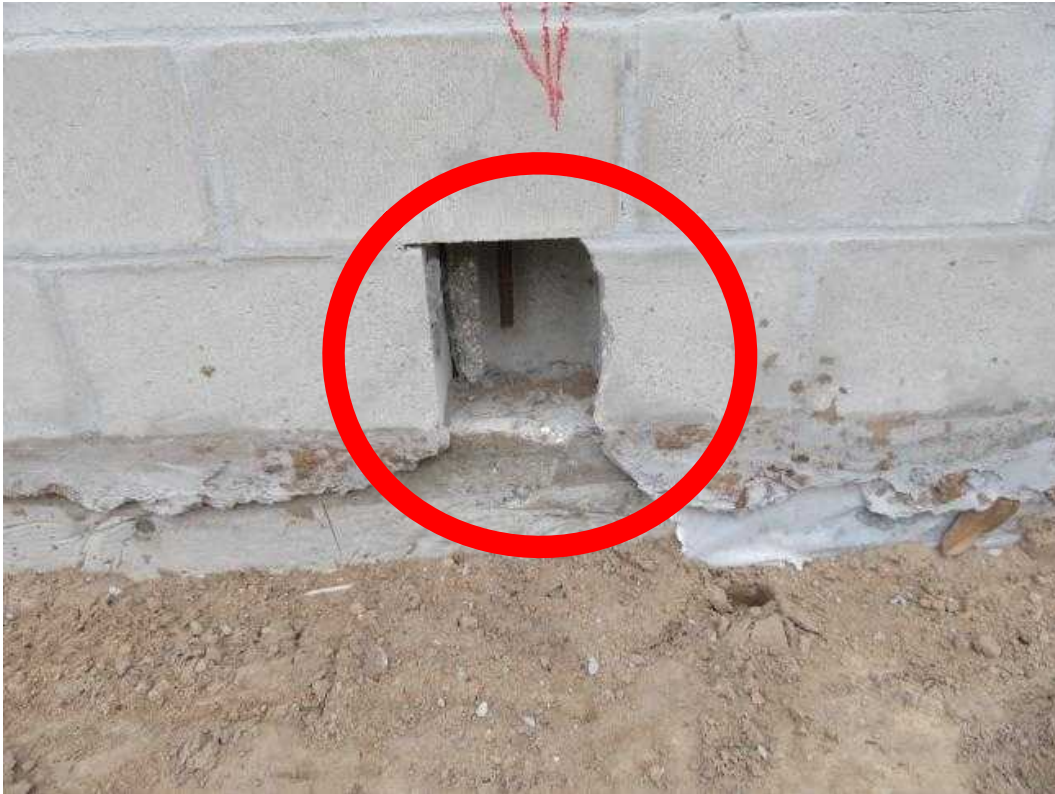
#2 2 dowels improperly placed. Missing footer dowels: at patio, left side near front, right side near center, left front of garage

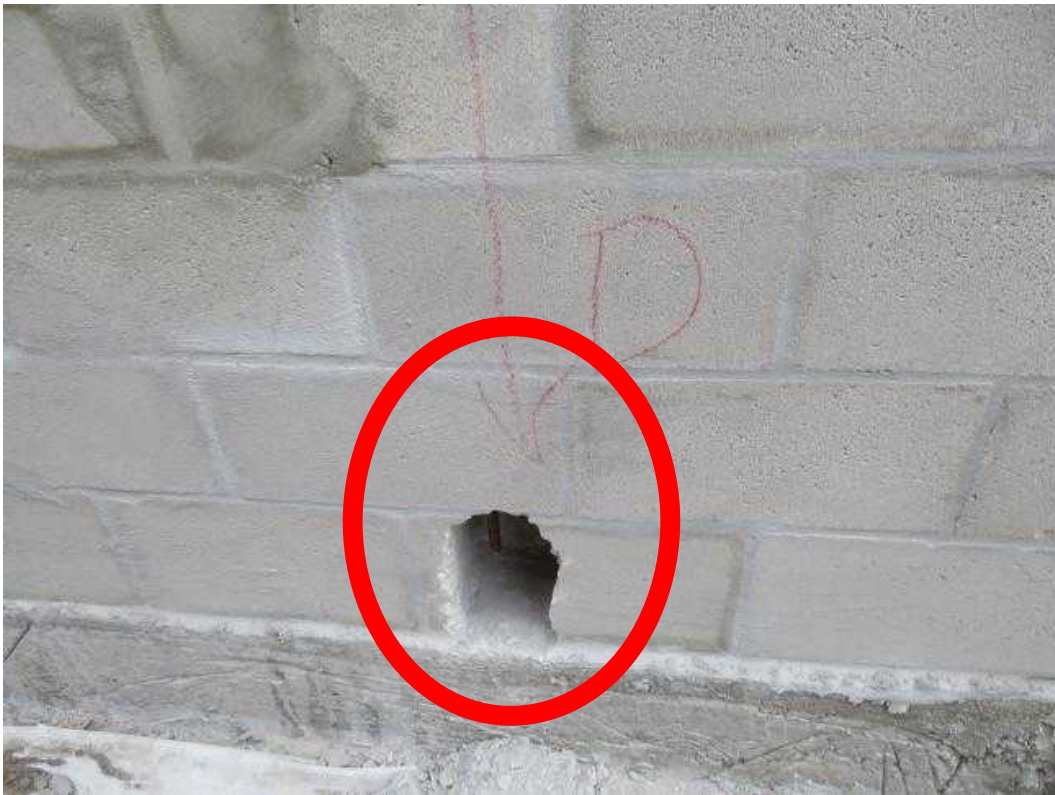
#3 Missing total of 4 footer dowels

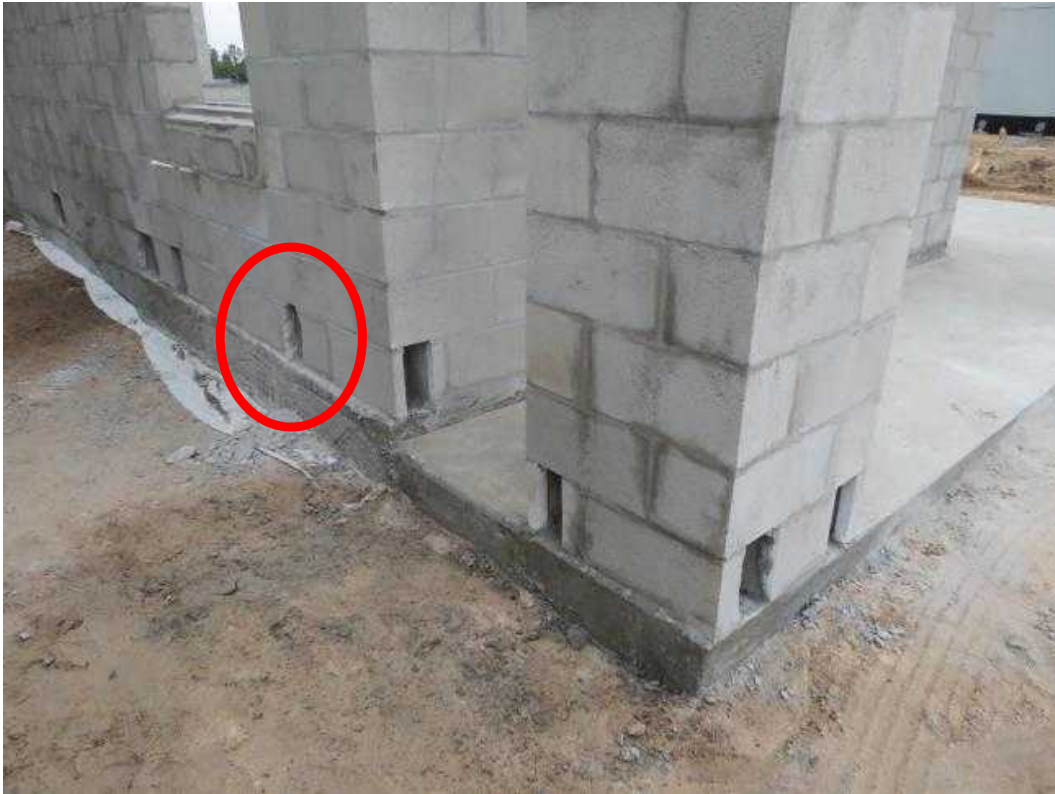
#4 Missing total of 4 footer dowels

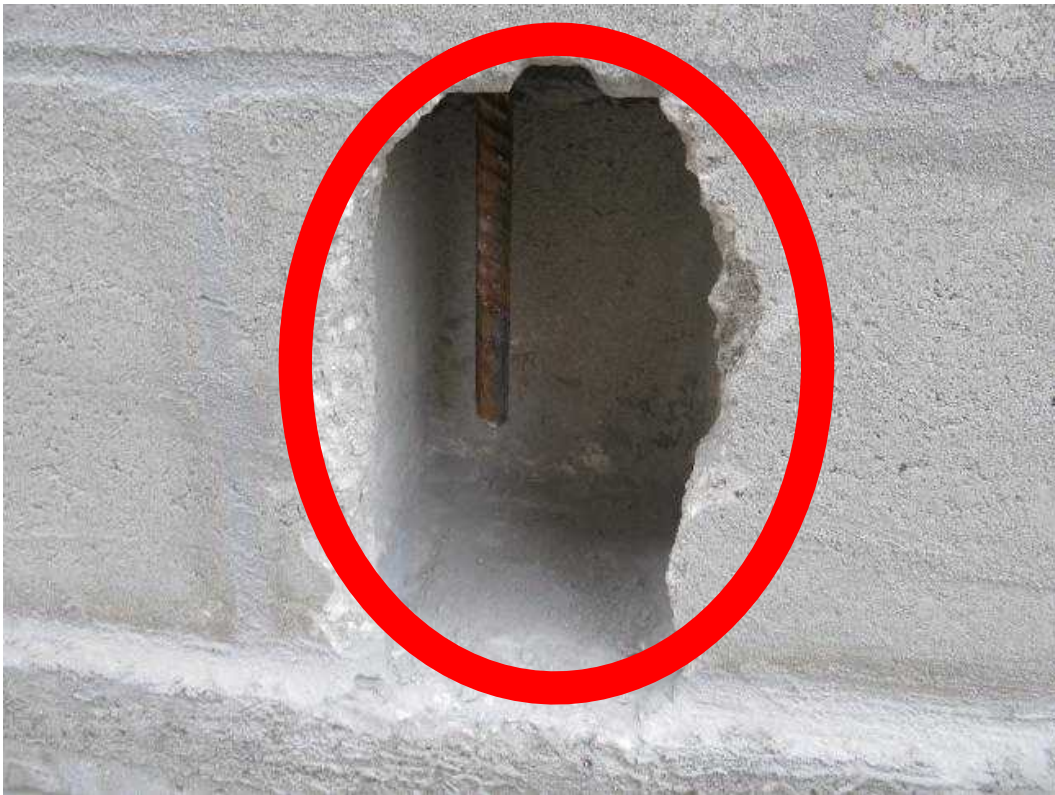
#5 Missing total of 4 footer dowels

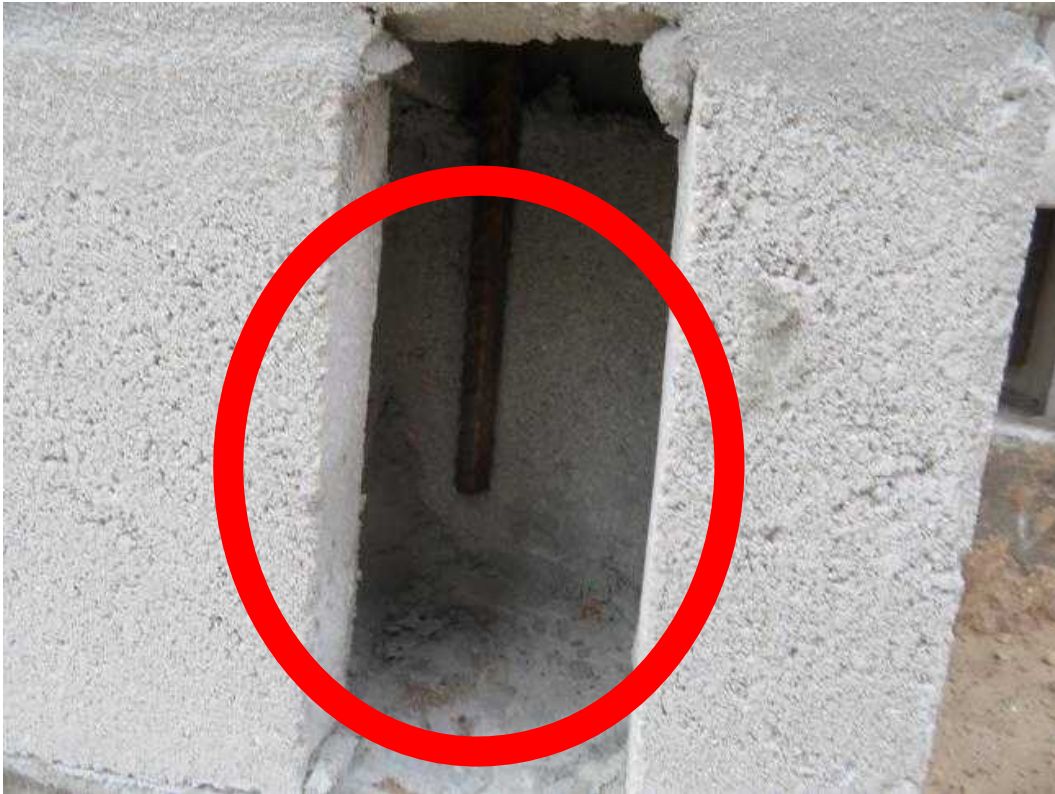
#6 Missing total of 4 footer dowels

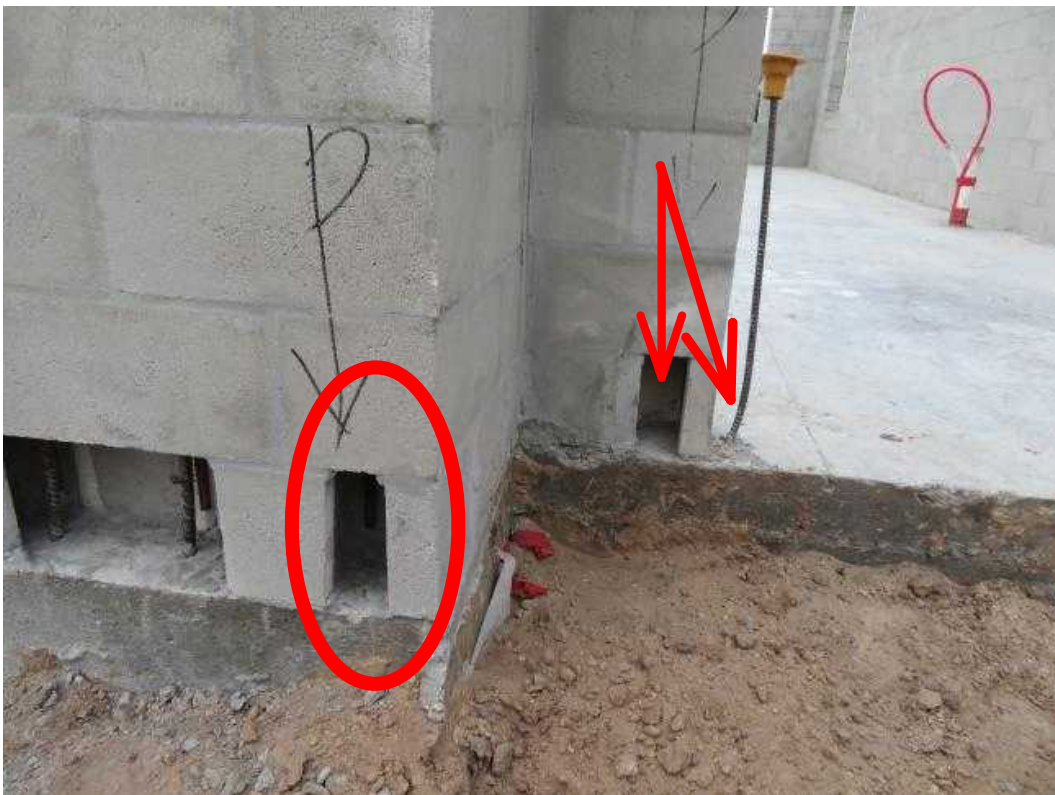
#7 Missing total of 4 footer dowels

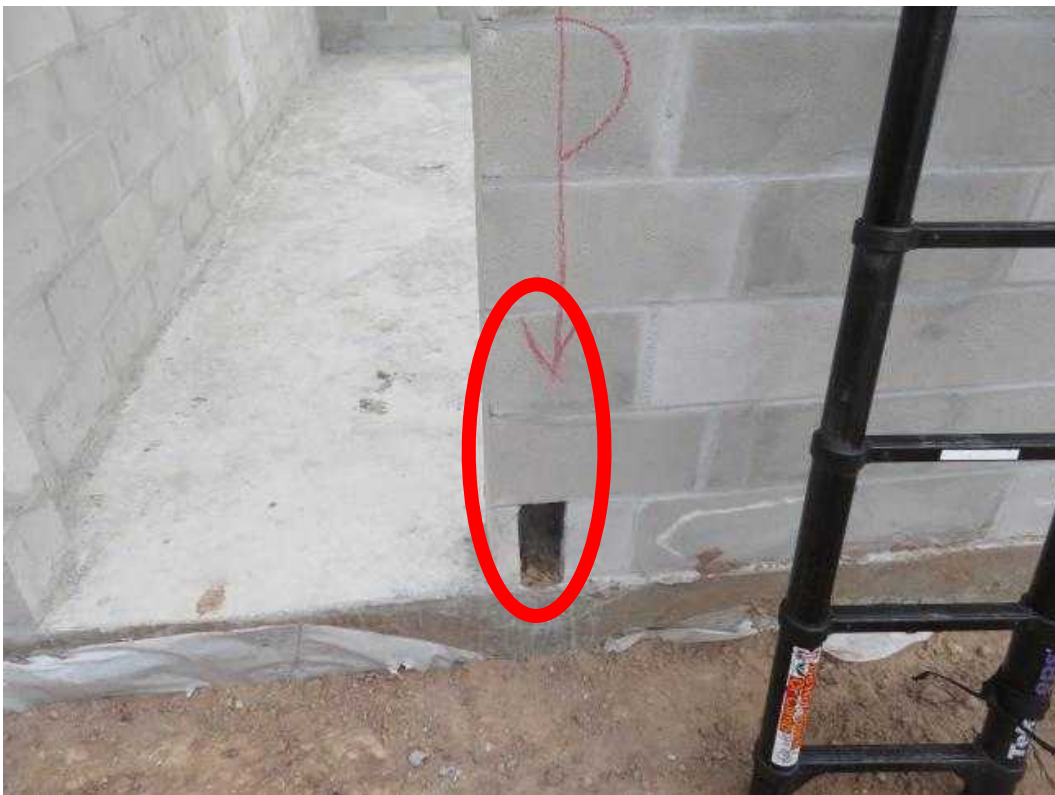
#9 Black: dowels placed improperly. Red: missing footer dowels

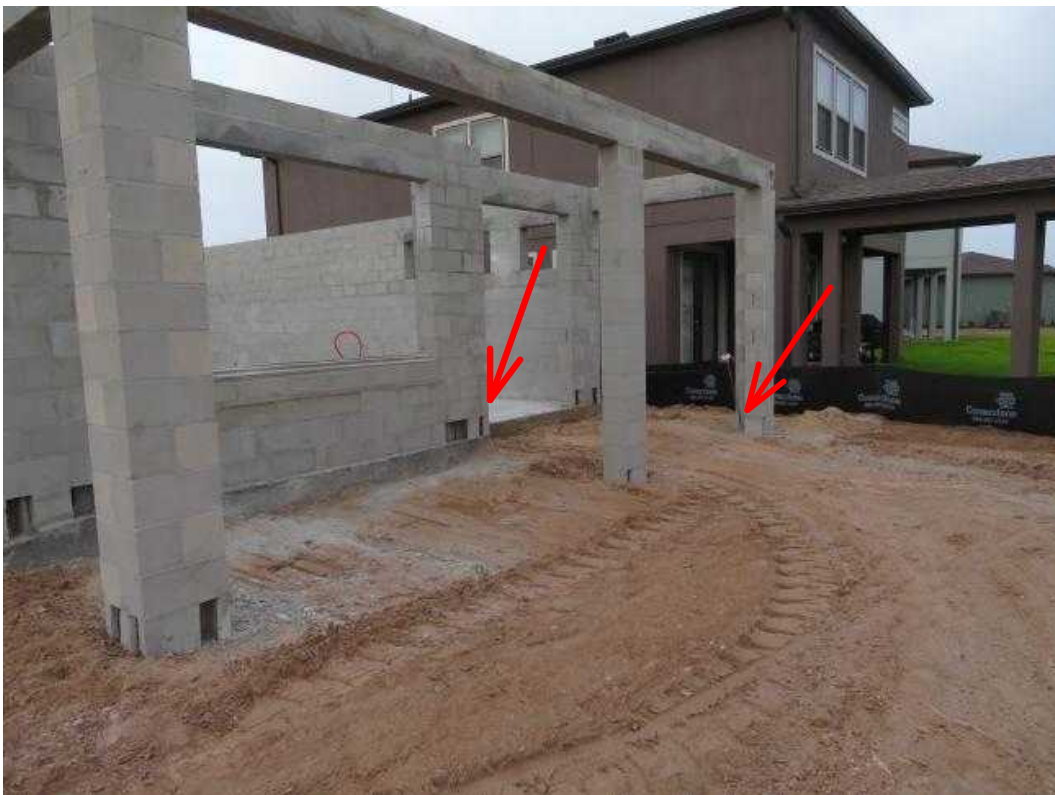
#13 Dowels placed improperly at slab pour at 2 places

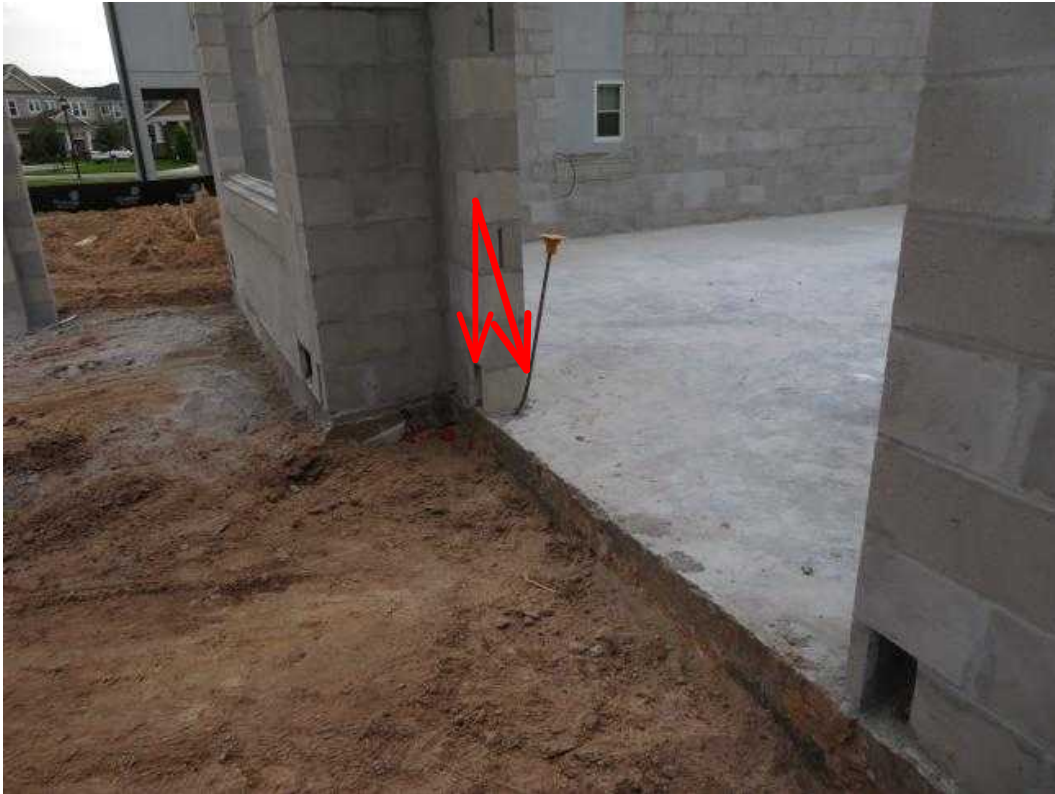
#14 Dowels placed improperly at slab pour at 2 places

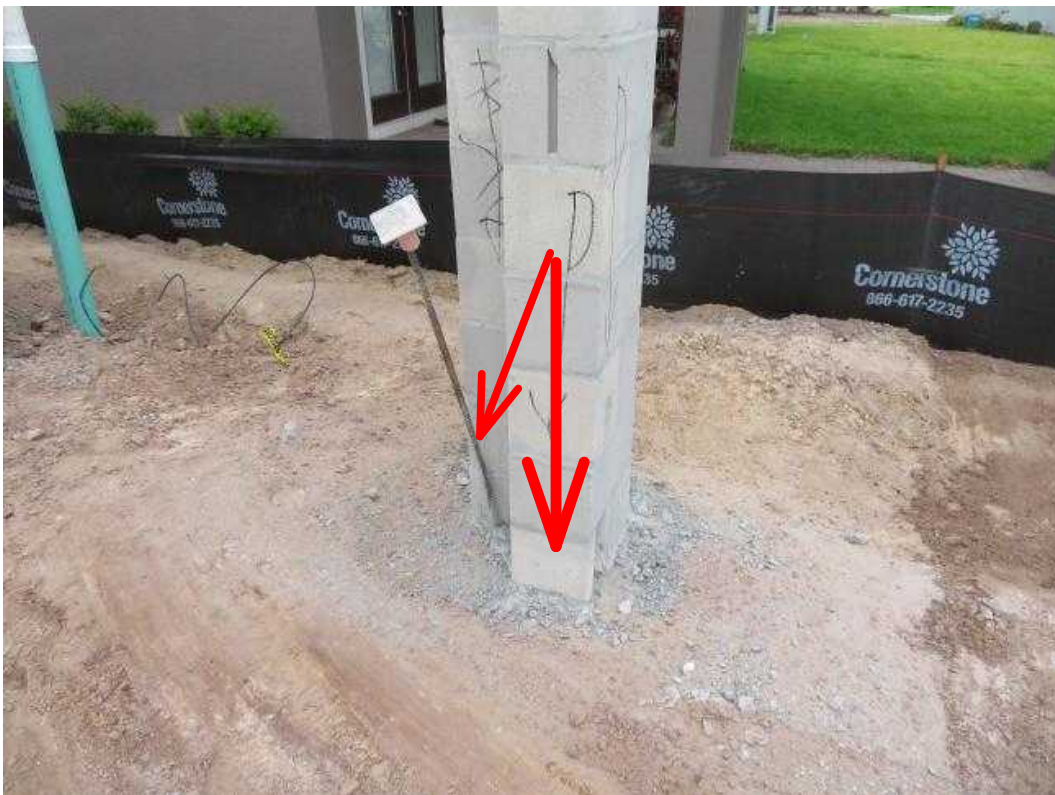
#15 Dowels placed improperly at slab pour at 2 places

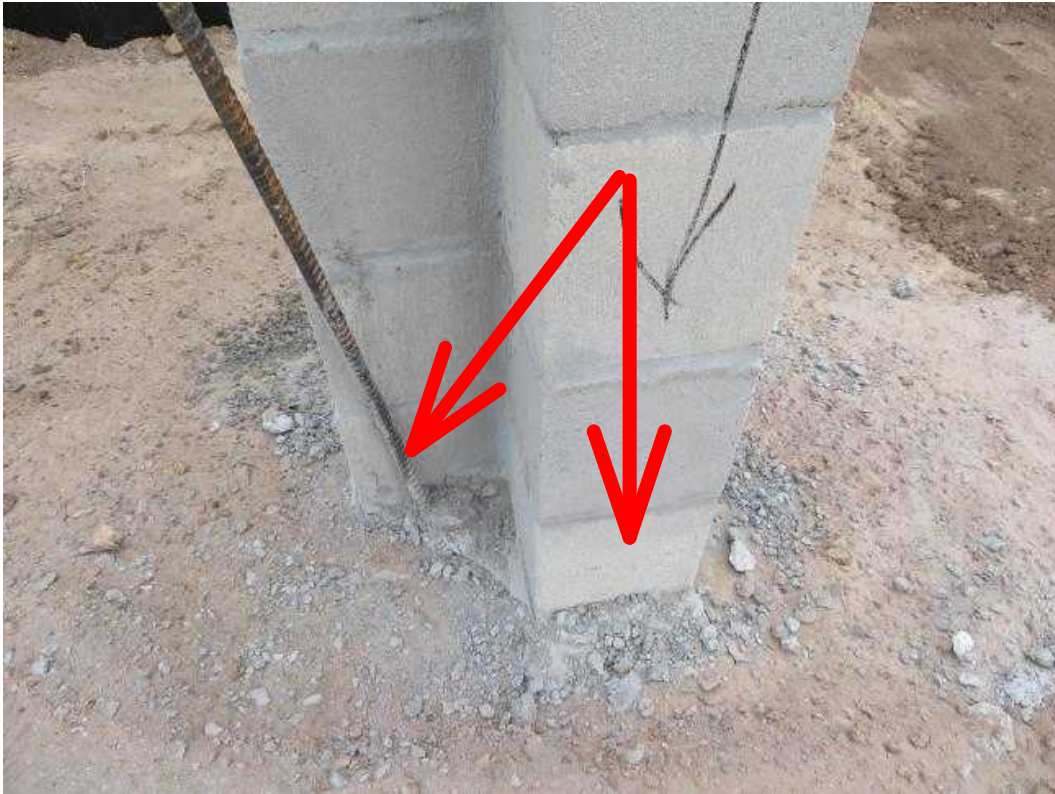
#16 Dowels placed improperly at slab pour at 2 places

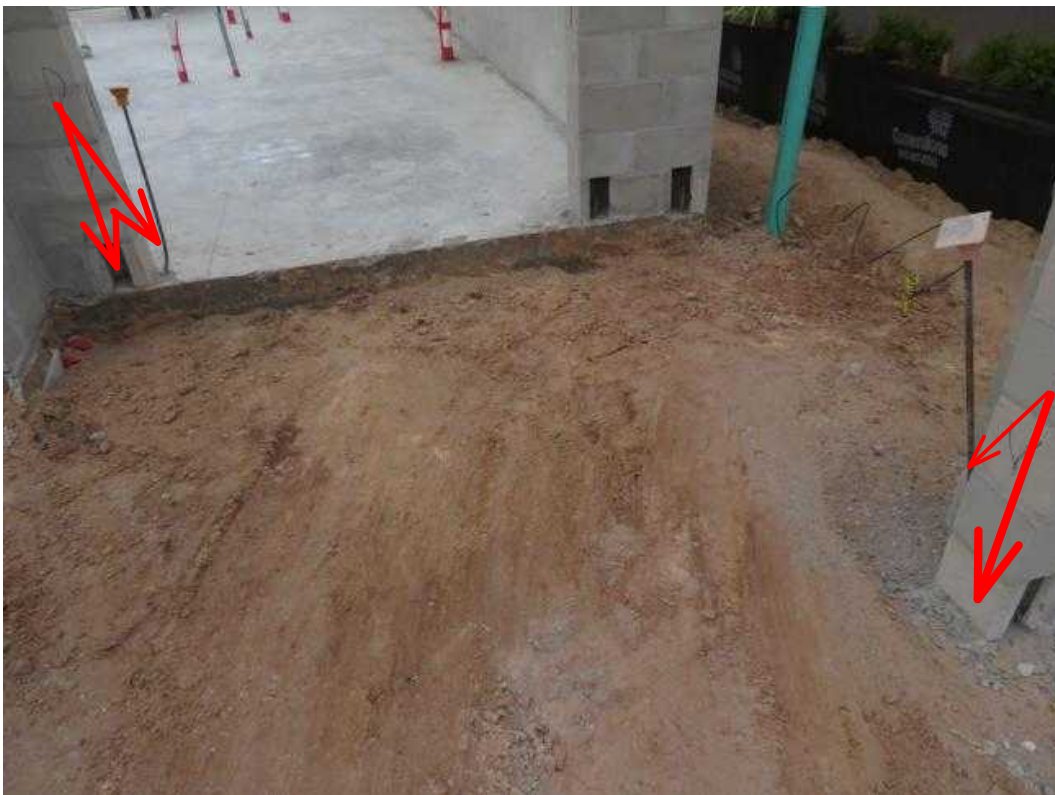
#17 Dowels placed improperly at slab pour at 2 places

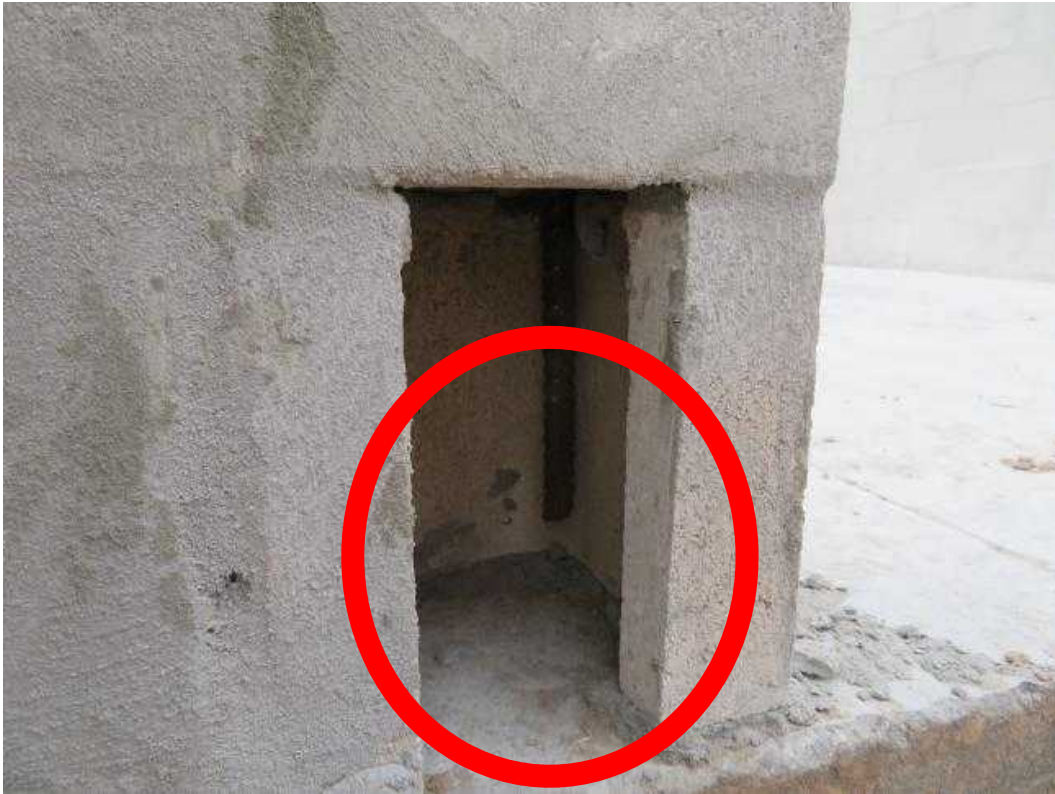
#18 Dowels placed improperly at slab pour at 2 places

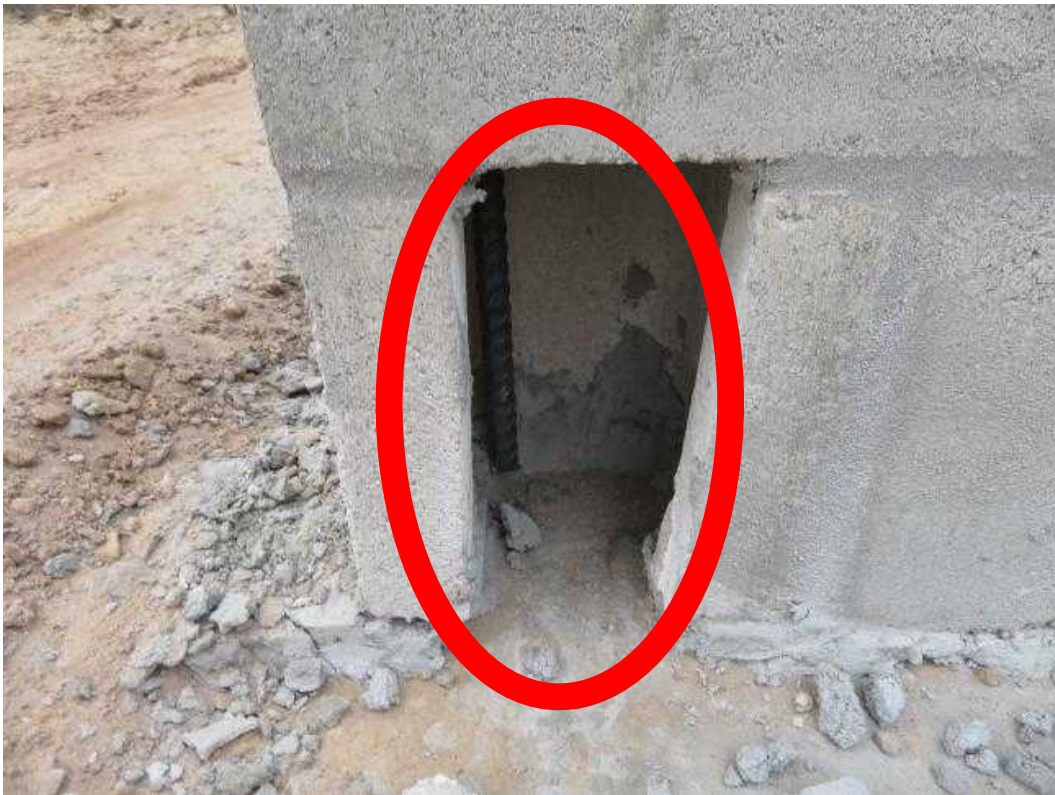
#19 Footer dowel missing. All dowels were present at footer inspection

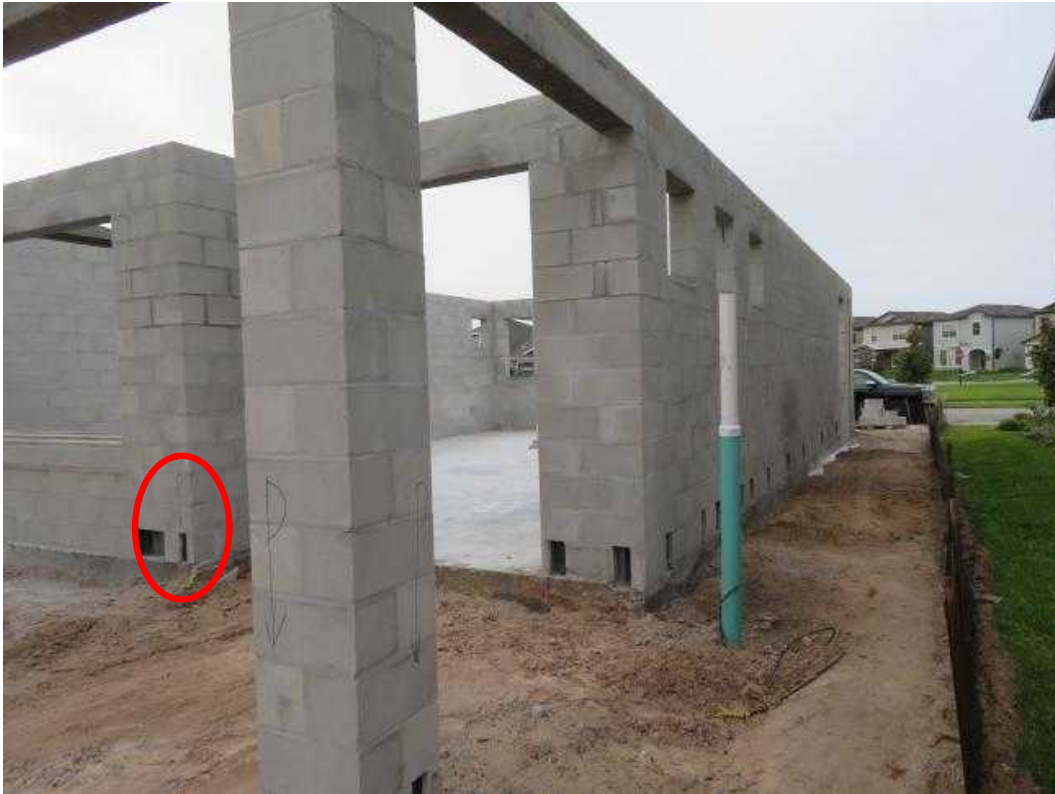
#20 Missing total of 4 footer dowels

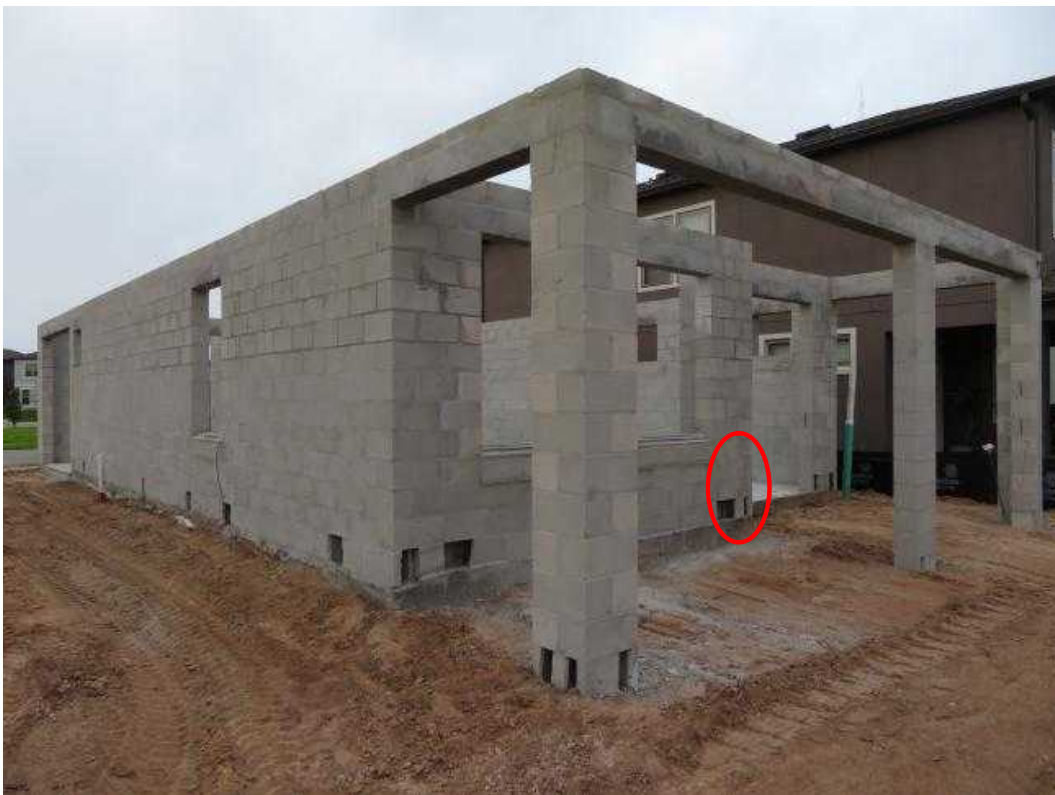
#21 Missing total of 4 footer dowels

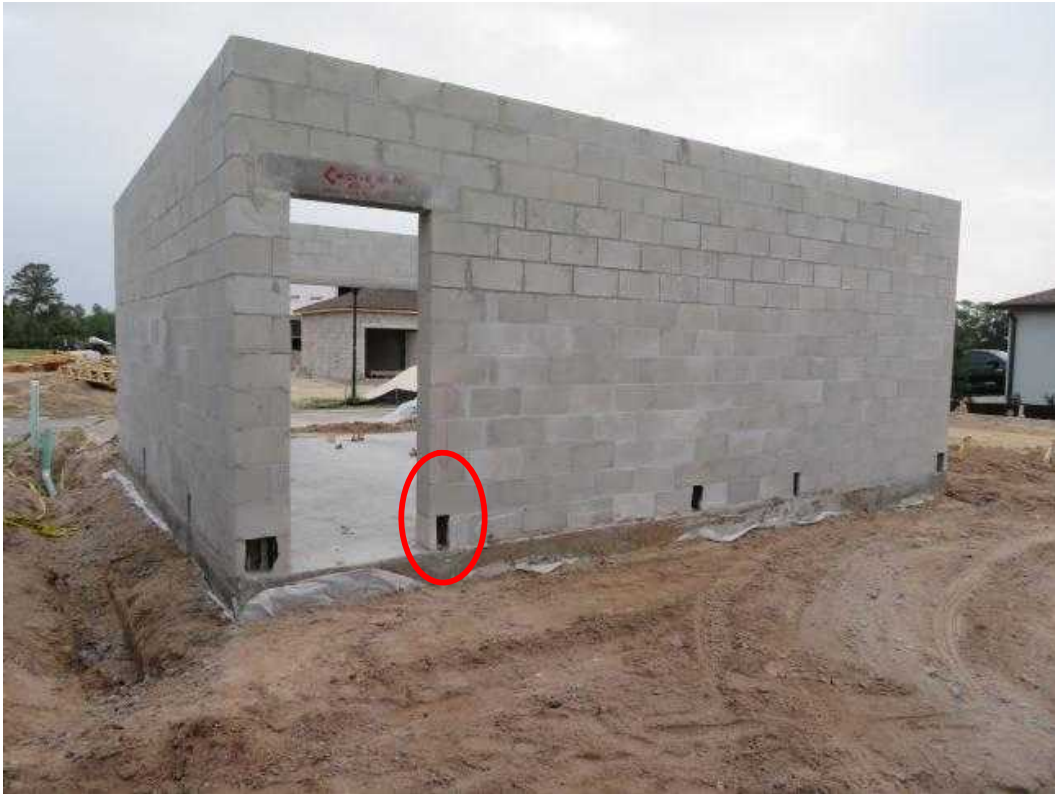
#22 Missing total of 4 footer dowels

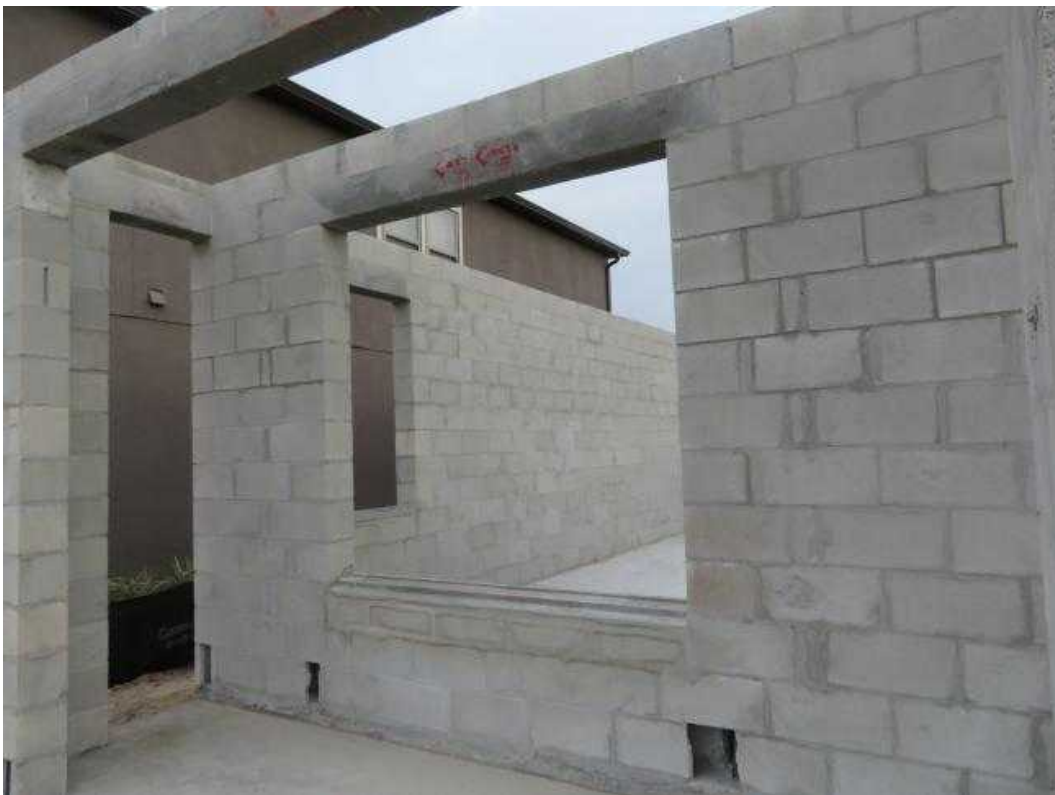
#23 Missing footer dowel at garage
