## Table of Contents

Inspector Name Darren Anderson  
Company Name Anderson Home Inspection Service, LLC

### Main roof Roof Framing

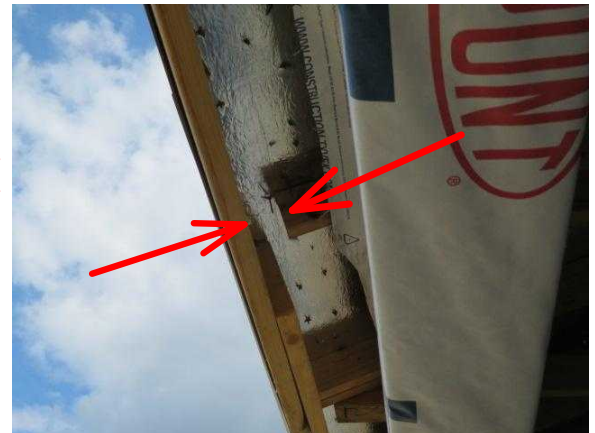
- Type: Gable, Hip
- Method of Inspection: On roof
- Unable to Inspect: 10%
- Satisfactory Roof Covering: Asphalt shingles
- Unsatisfactory Trusses: 2x4 2 of the truss tips were cut too short to accommodate the wood fascia located at the rear above the patio. The framing contractor was present and advised that he will repair this condition on 5-24-18.

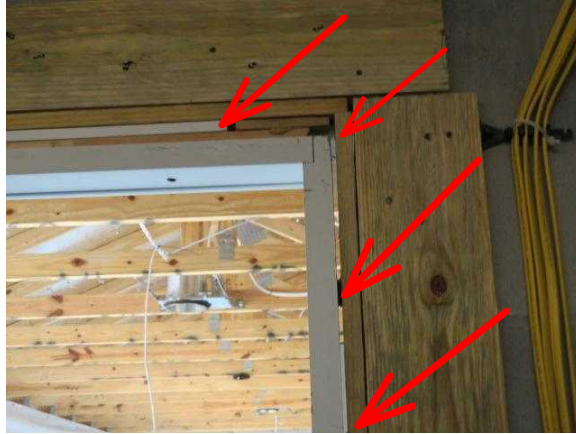
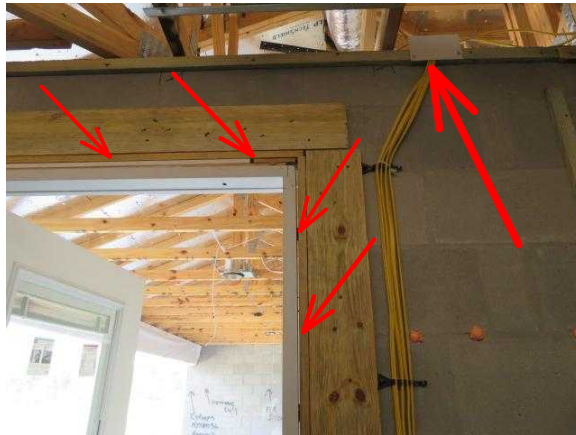
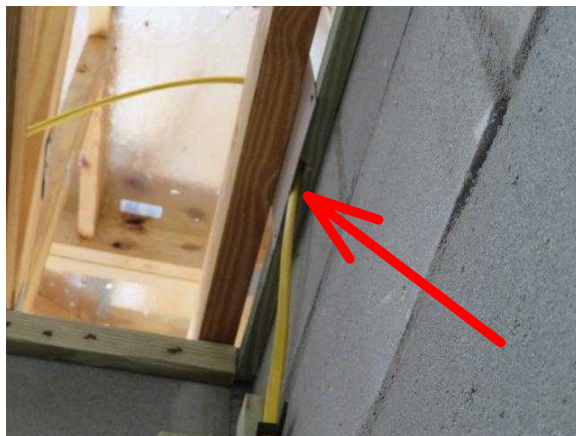
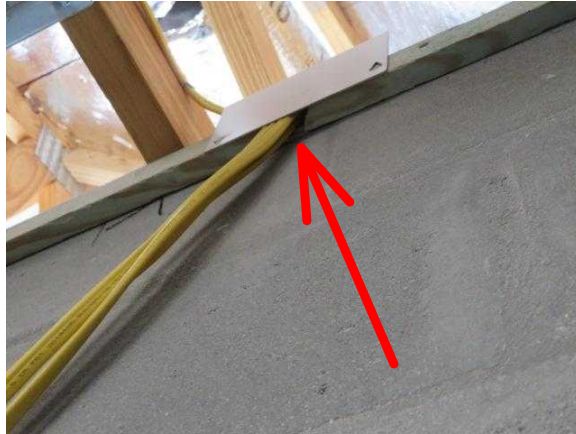
1. Unsatisfactory Wall Sill Sealer: Closed cell foam Observed some penetrations and around the door inside of the pool bathroom that are missing the foam seals.

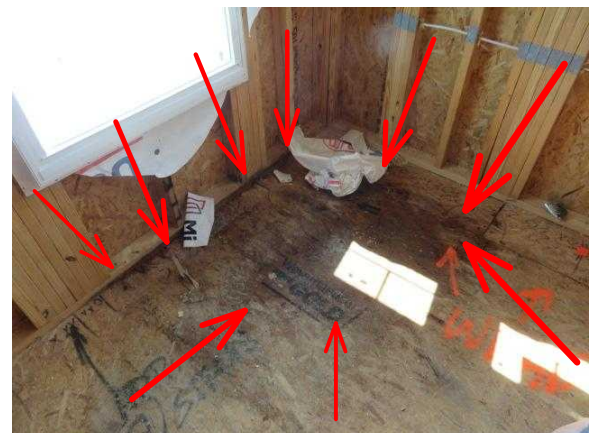
2. Unsatisfactory Floor Sheathing: Strand board **Observed some sub flooring damage at the 2nd floor front room which appears to be water damage. (The windows was likely left out for materials delivery and rain entered the structure) Recommend further evaluation by a licensed contractor as the damage appears to contain some moldy substances. Recommend replacing the damaged sub flooring in this area and making any necessary repairs to correct any mold-related**

conditions if present.

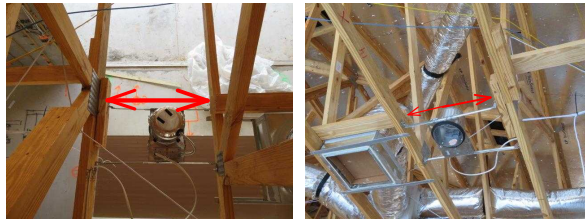
Cross Bridging: 2x4 wood The cross bracing located at the family room has been removed/cut to install a recessed light fixture. A framing contractor was present and made the repair which appears to be sufficient.

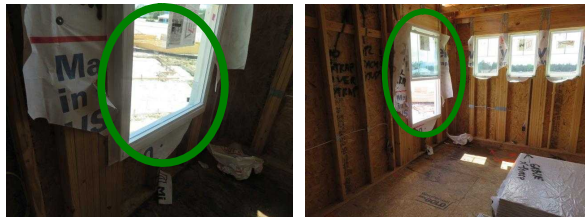
Window Installation: Improper installation A 2nd floor window is not installed properly which is likely due to allow for materials deliveries.

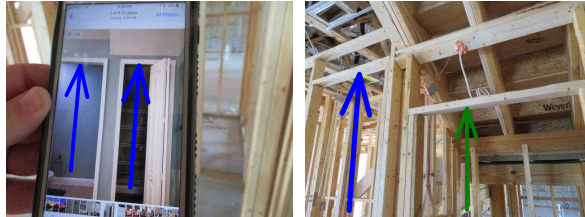
Door Framing: Block, 2x4 wood The client has a photo of the model that has the door under the stairs the same as the other doors being 96" tall opening. The framing for this house is a 80" framed opening. The correct opening size was not identified. The construction supervisor advised that he will investigate this condition.

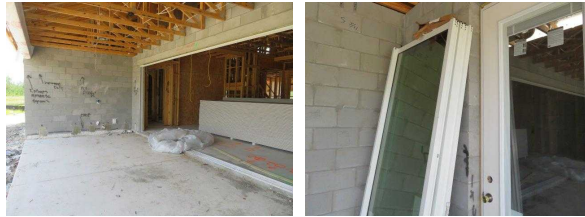
Exterior Door Installation: Properly installed The sliding patio doors are not installed into the door tracks.

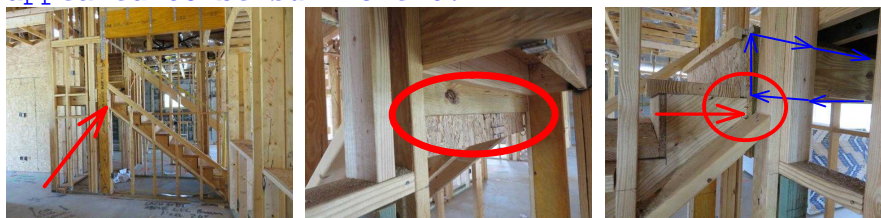
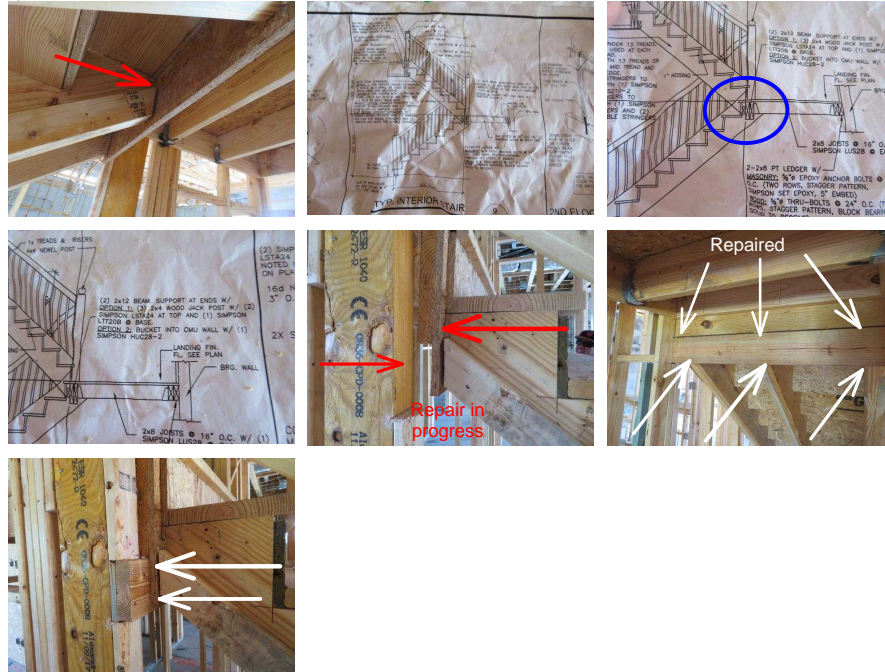
3. Satisfactory Stringers: 2x12 Wood The lower set of stairs do not line up to rest against the landing and a board has been nailed below the landing with a piece of OSB sheathing for the stairs to mount against. This appears to be a very weak attachment and appears to be substandard in nature. The framing contractor arrived during the inspection and he observed the stairs and agreed that the stairs need repairs to prevent a catastrophic event or failure. He made the repairs while this inspector was present. His repairs appeared to be sufficient.

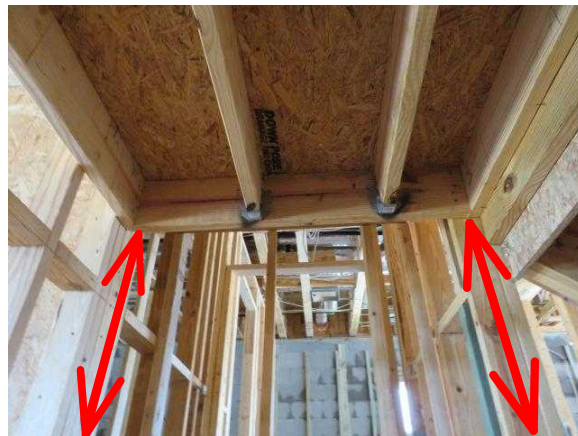
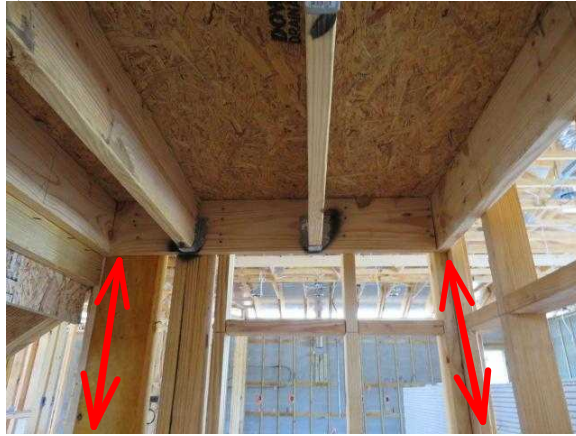
Recommend installing jack studs to support the mid landing. The framing contractor was present and advised that he would make the repair on 5-24-18.

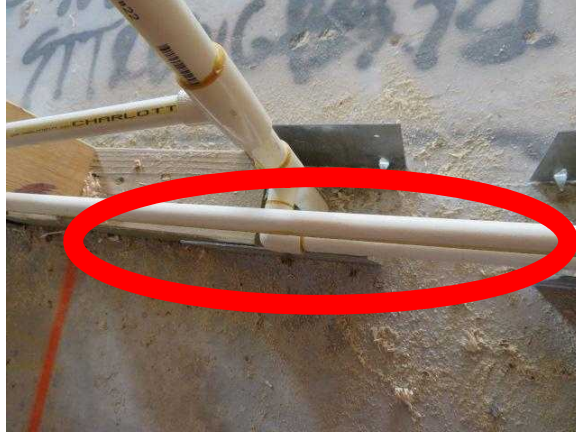
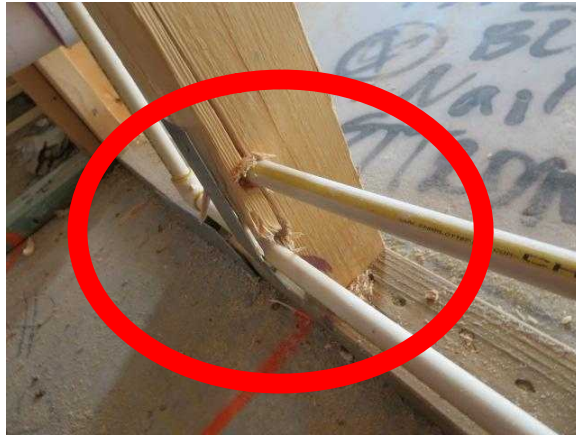
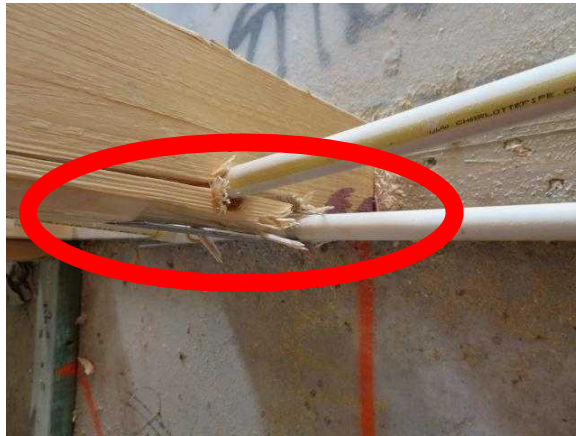
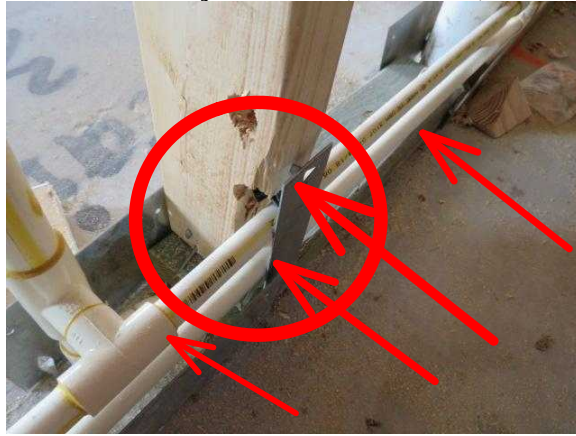
- 1. Satisfactory Verify permit inspections are completed and approved
- 2. Satisfactory Main service sealed at wall penetration
- 3. Unsatisfactory Supply piping complete and securely installed **Some of the plumbing supply pipes at bathrooms are routed in what appears to be a substandard nature. The pipes protrude the walls where the drywall will be installed in some places and the wood framing is split where some of the piping has been routed. Recommend re-routing the plumbing pipes to prevent the drywall from touching the pipes. Recommend further evaluation by a licensed plumbing contractor.**

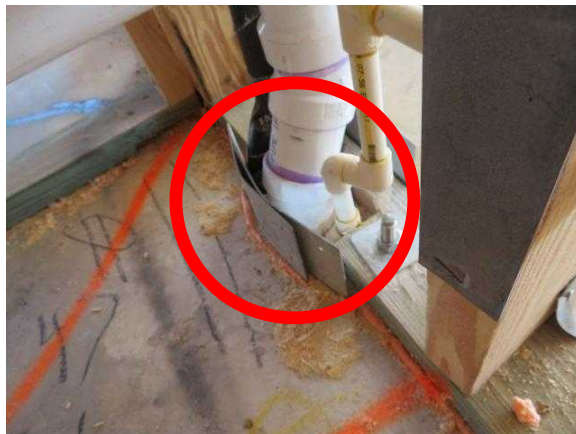
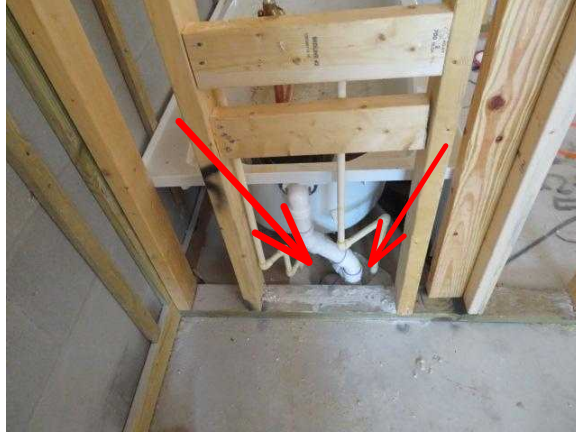
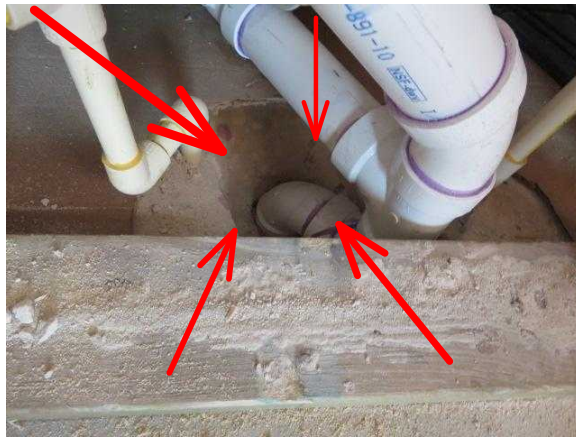
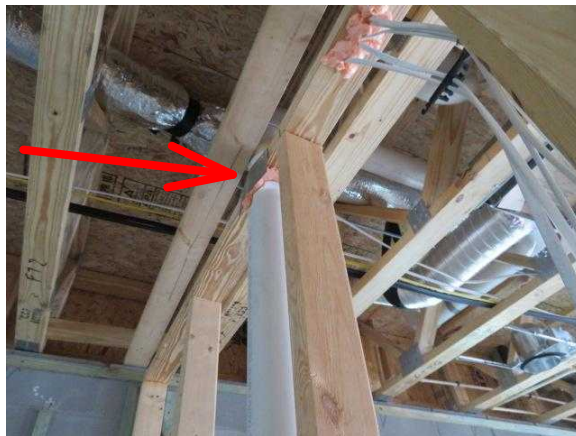
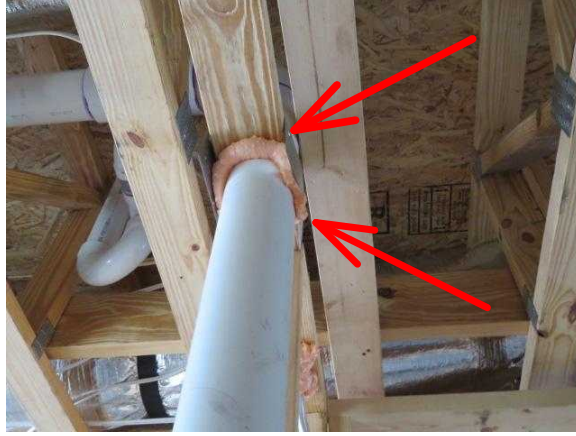
Sanitary drain piping complete, properly sized and securely installed. A plumbing drain line protrudes the wall by about an inch at a 1st floor bathroom and should be moved to accommodate the drywall.

Left 1st floor bathroom: The concrete has been chipped away to accommodate the tub drain and the concrete has not been filled/repared at this location.

The vertical plumbing drain for the upper level located at the master bedroom closet protrudes the wall framing. It appears that the plumbing pipe is routed about 1/2" out from the framed wall which will not allow the drywall to mount flush against the framing. This condition could cause excessive noise when water is being drained from the 2nd level.

Recommend further evaluation and repairs by a licensed plumbing contractor.

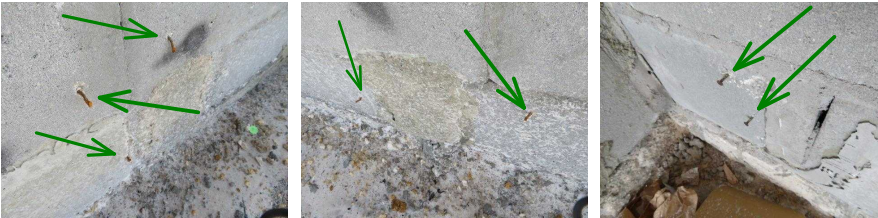
2. Exterior Bearing Walls: Block/frame Observed some nails in various places that need removal on the exterior walls in various places prior to the stucco application.

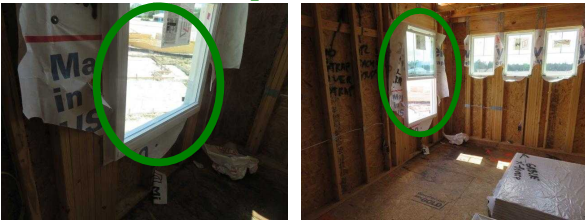
3. Window Installation: Improper installation A 2nd floor window is not installed properly which is likely due to allow for materials deliveries.

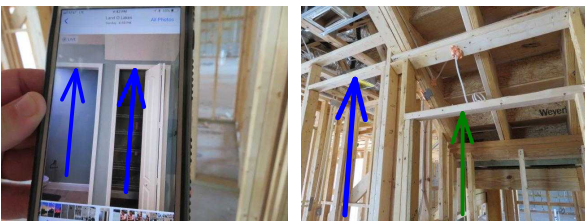
4. Door Framing: Block, 2x4 wood The client has a photo of the model that has the door under the stairs the same as the other doors being 96" tall opening. The framing for this house is a 80" framed opening. The correct opening size was not identified. The construction supervisor advised that he will investigate this condition.

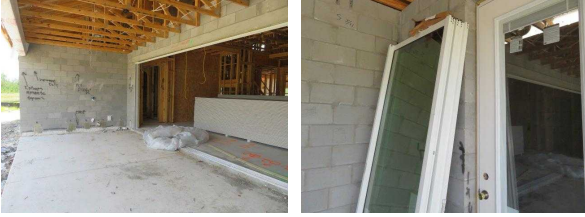
5. Exterior Door Installation: Properly installed The sliding patio doors are not installed into the door tracks.

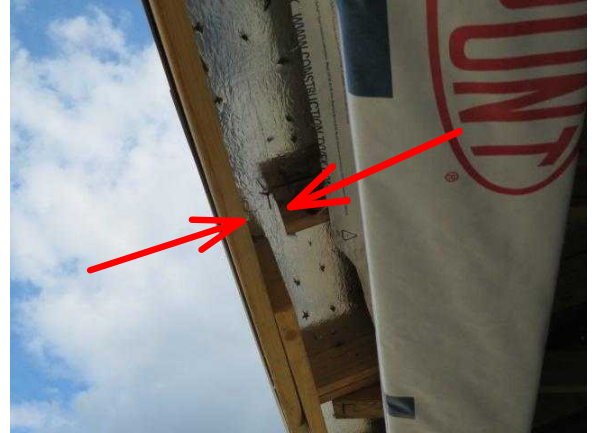
1. Main roof Roof Framing Trusses: 2x4 2 of the truss tips were cut too short to accommodate the wood fascia located at the rear above the patio. The framing contractor was present and advised that he will repair this condition on 5-24-18.

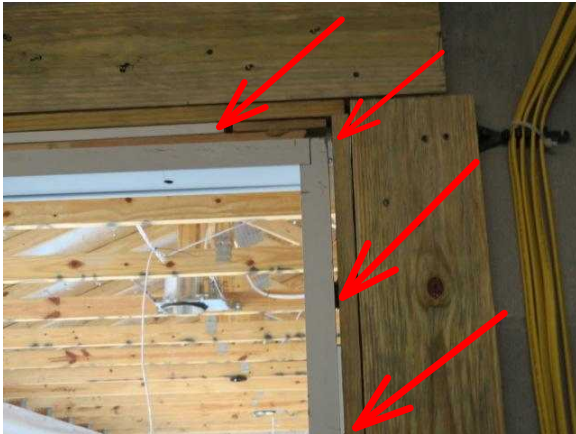
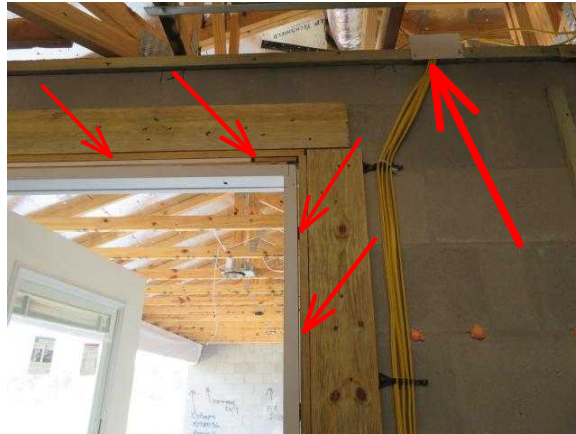
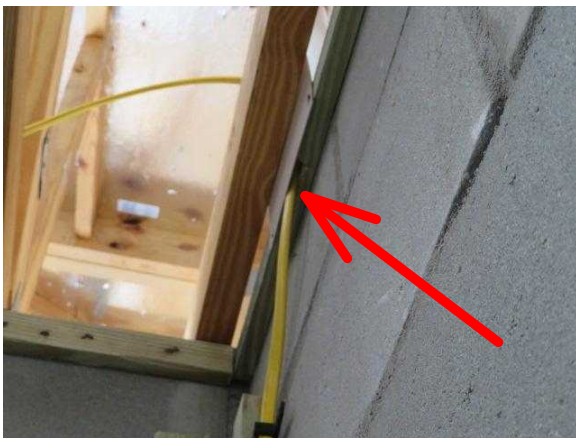
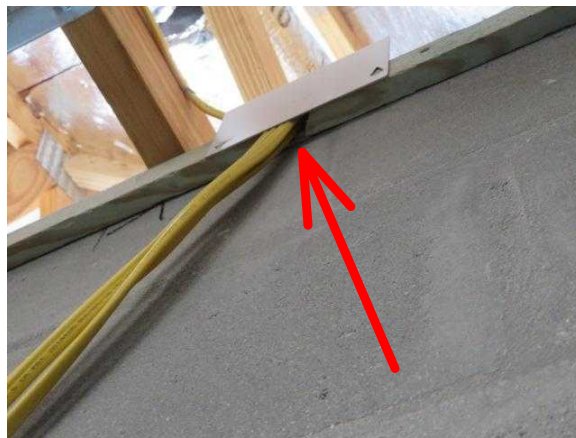
2. Wall Sill Sealer: Closed cell foam Observed some penetrations and around the door inside of the pool bathroom that are missing the foam seals.

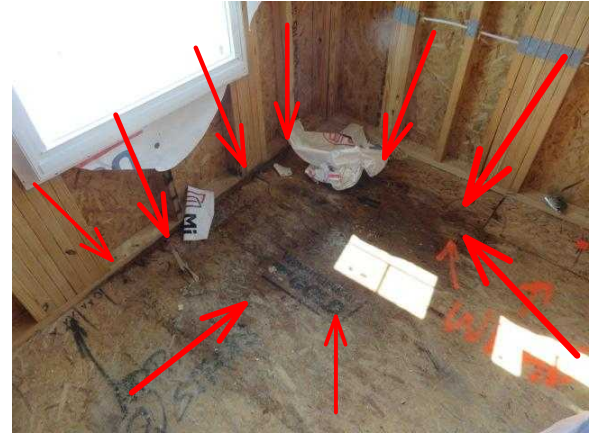
3. Floor Sheathing: Strand board Observed some sub flooring damage at the 2nd floor front room which appears to be water damage. (The windows was likely left out for materials delivery and rain entered the structure) Recommend further evaluation by a licensed contractor as the damage appears to contain some moldy substances. Recommend replacing the damaged sub flooring in this area and making any necessary repairs to correct any mold-related conditions if present.

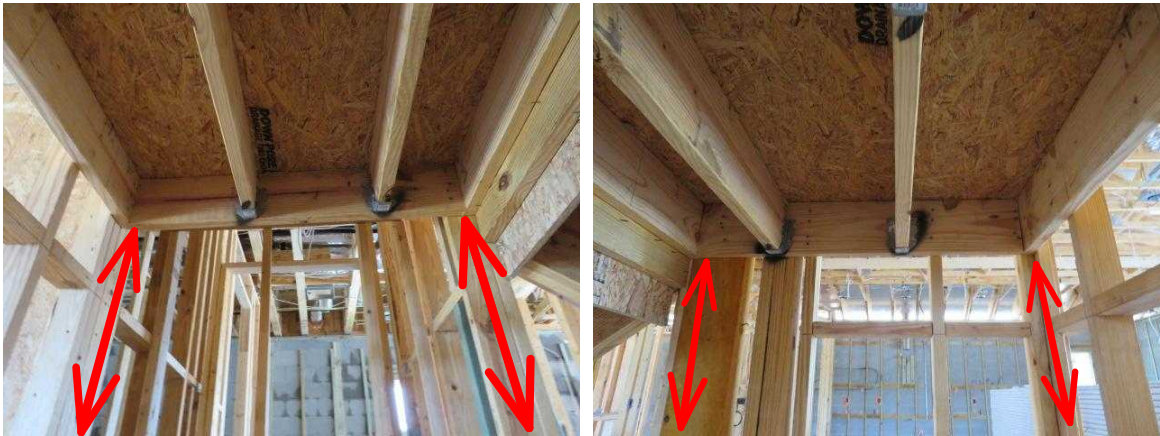
4. Main staircase Stair Framing Platforms/Landings: Site-built Recommend installing jack studs to support the mid landing. The framing contractor was present and advised that he would make the repair on 5-24-18.

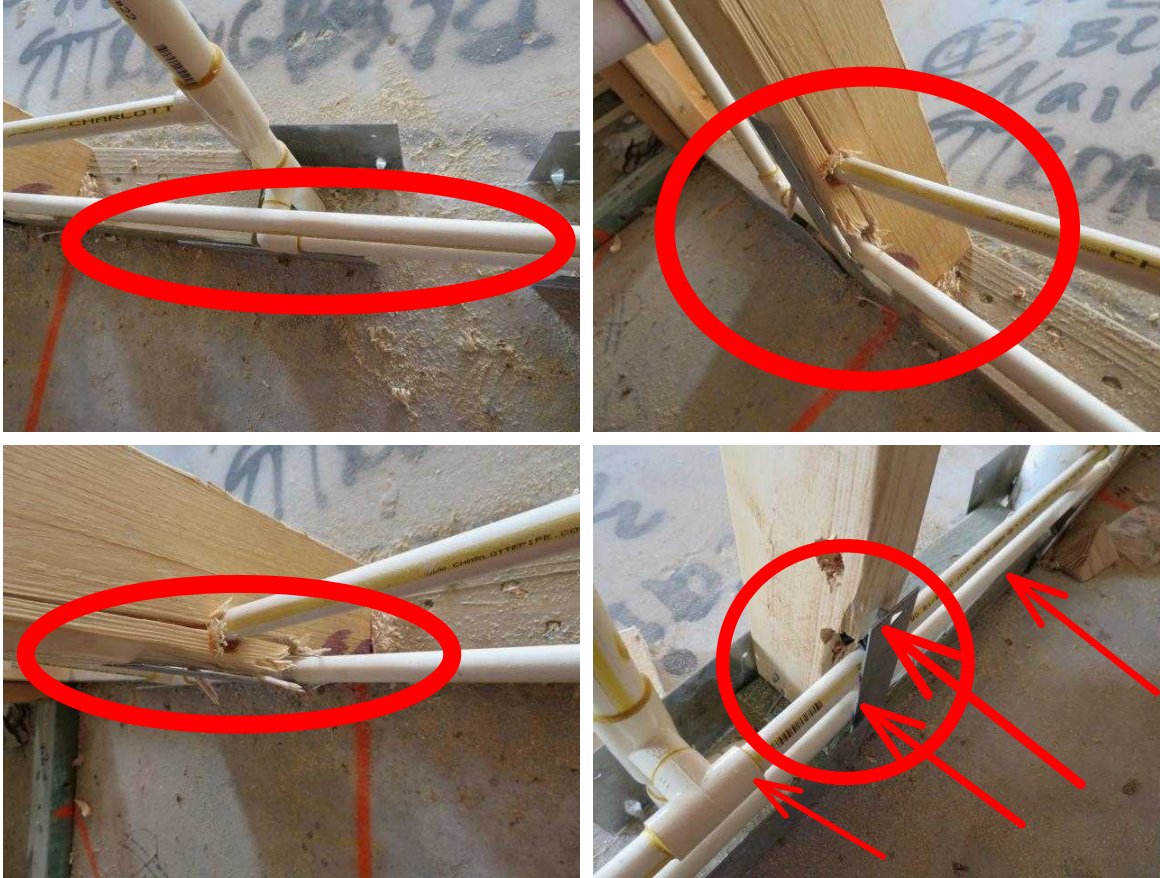
5. All Plumbing Supply piping complete and securely installed Some of the plumbing supply pipes at bathrooms are routed in what appears to be a substandard nature. The pipes protrude the walls where the drywall will be installed in some places and the wood framing is split where some of the piping has been routed. Recommend re-routing the plumbing pipes to prevent the drywall from touching the pipes. Recommend further evaluation by a licensed plumbing contractor.

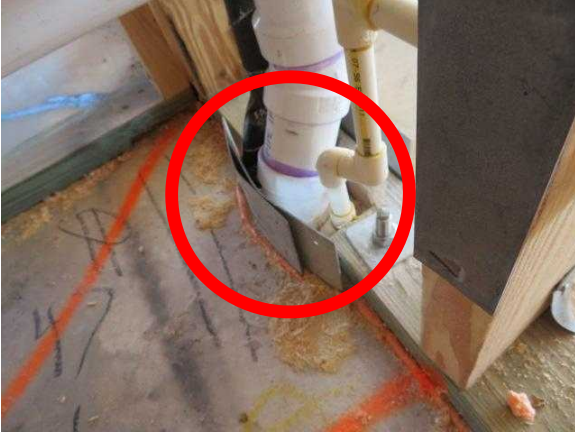
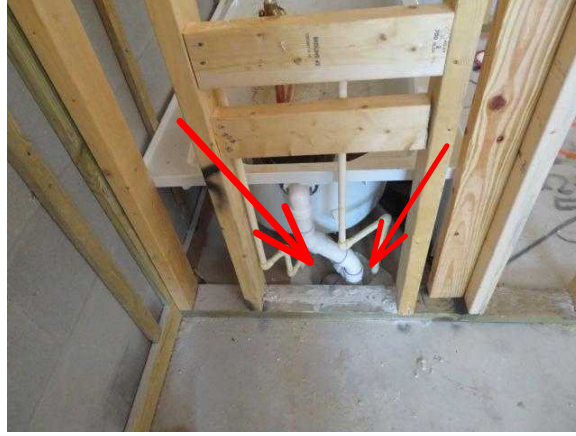
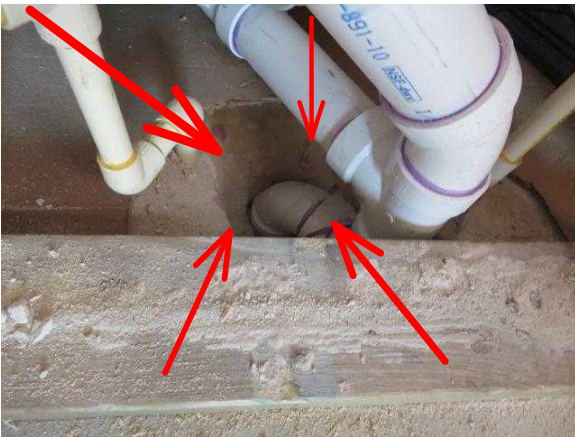
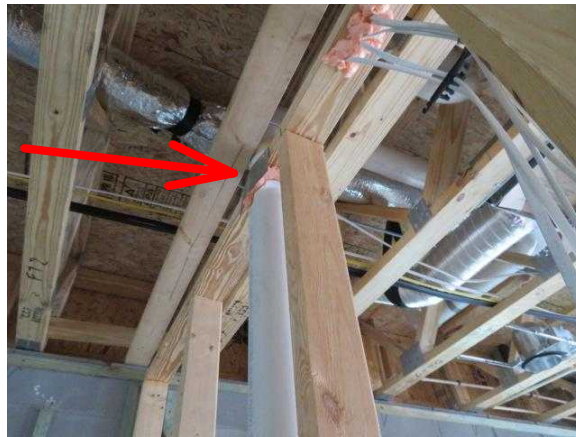
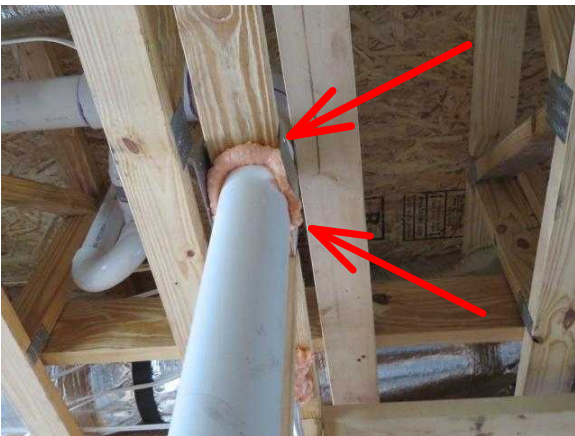
6. All Plumbing Sanitary drain piping complete, properly sized and securely installed A plumbing drain line protrudes the wall by about an inch at a 1st floor bathroom and should be moved to accommodate the drywall.

Left 1st floor bathroom: The concrete has been chipped away to accommodate the tub drain and the concrete has not been filled/repared at this location.

The vertical plumbing drain for the upper level located at the master bedroom closet protrudes the wall framing. It appears that the plumbing pipe is routed about 1/2" out from the framed wall which will not allow the drywall to mount flush against the framing. This condition could cause excessive noise when water is being drained from the 2nd level.

Recommend further evaluation and repairs by a licensed plumbing contractor.
