Table of Contents

Inspector Name Darren Anderson
Company Name Anderson Home Inspection Service, LLC

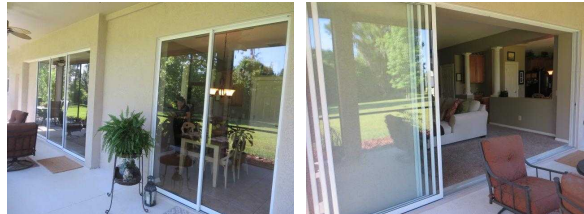
- 9. Defective

Windows: Aluminum, Single hung, Fixed in place, Single pane glazing, Sliding **Observed voids and loose caulking around the exterior window perimeter in some places which can allow water intrusion. There is some moldy caulking present with plant growth growing out of the caulking which indicates that moisture is being trapped under the caulking.**
There are two windows in the living room and the lower glazing for each window is less than 18 inches from the floor and the glazing did not appear to be etched to indicate the presence of tempered safety glass. Current Florida Building Code requires glazing within 18 inches of the floor to be safety glass. Recommend further evaluation by a licensed Glazer contractor. 2406.3 Identification of safety glazing.
Except as indicated in Section 2406.3.1, each pane of safety glazing installed in hazardous locations shall be identified by a

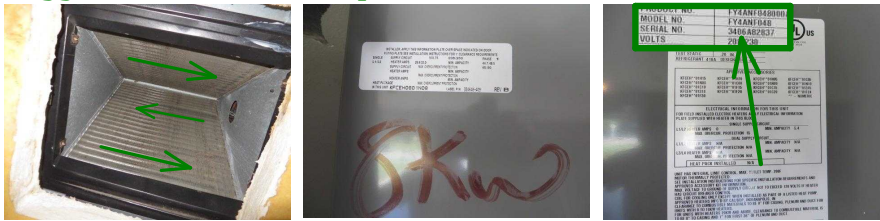
The evaporator coils are dirty and needs to be cleaned. This condition restricts sufficient air flow which can cause a system malfunction, overheating and poor performance.

Suggest evaluation by a licensed HVAC contractor.

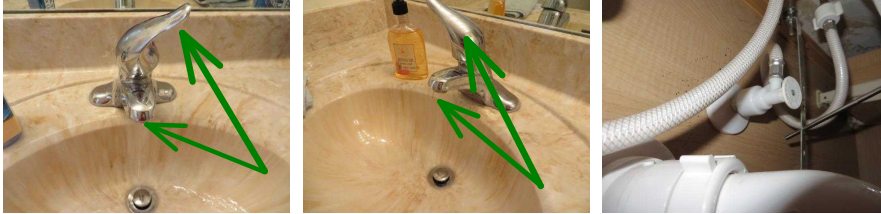
condition. Recommend further evaluation and repairs by a licensed plumber.
